**SECOND
HALF**

MAINTENANCE

The most important program on the maintenance of the cubers machines is the cleaning/sanitizing to be done on regular base as detailed here below

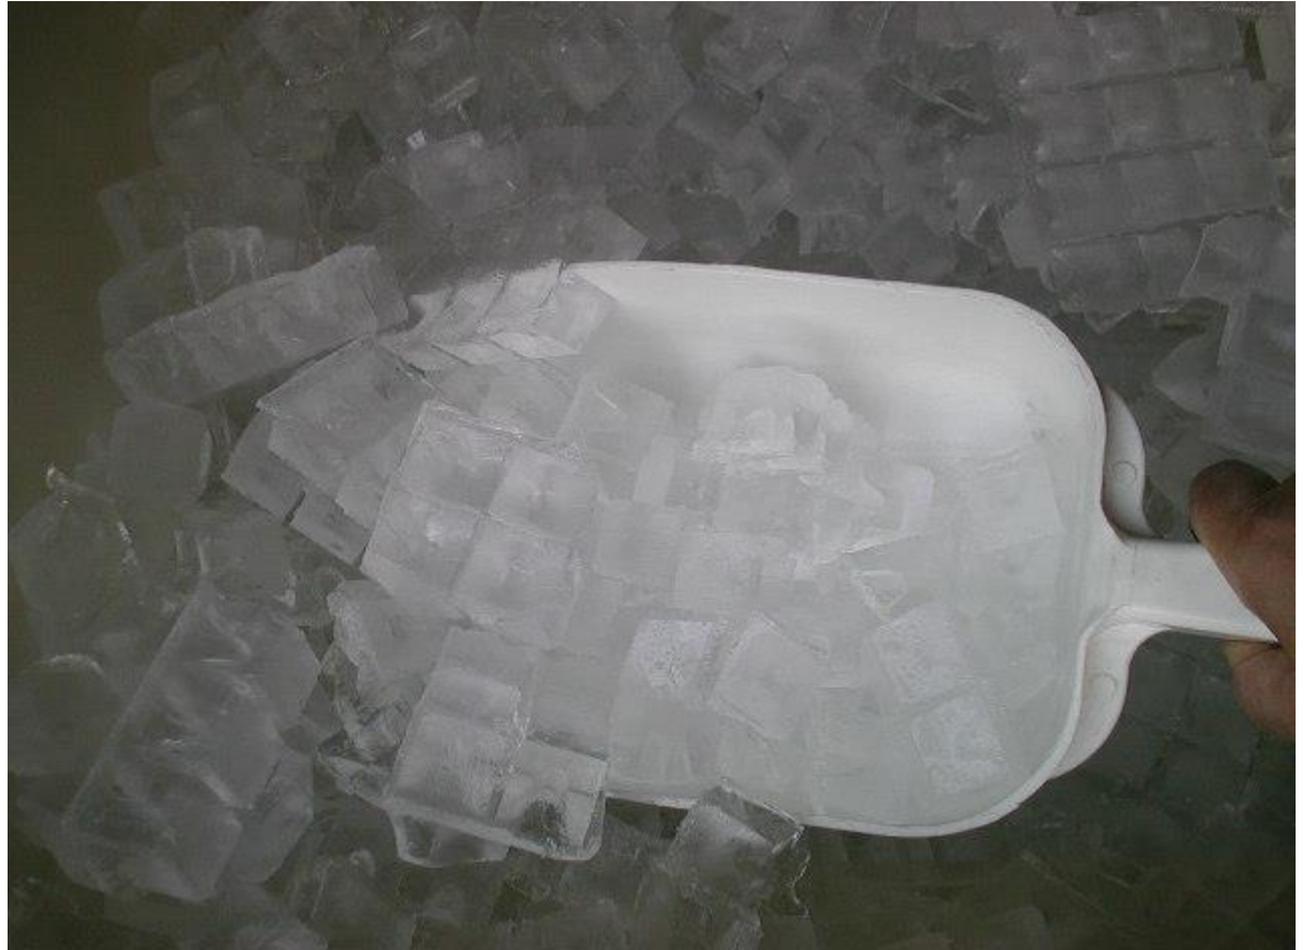
Scoop out all
ice cubes
stored into the
bin so to
prevent its
contamination
then...

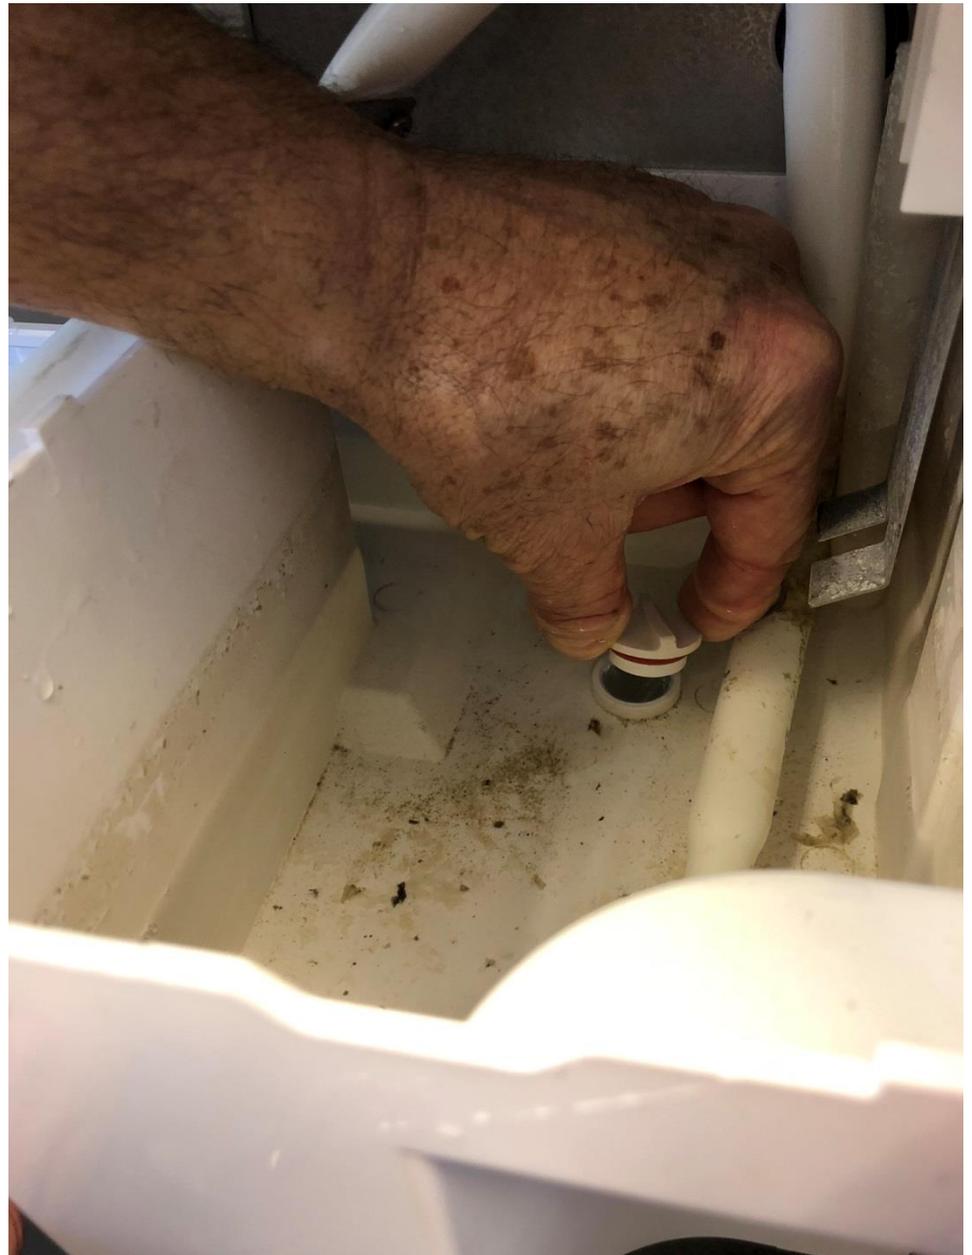
Be assured
water sump is
empty by water.

In case dump
the same by
removing drain
plastic plug

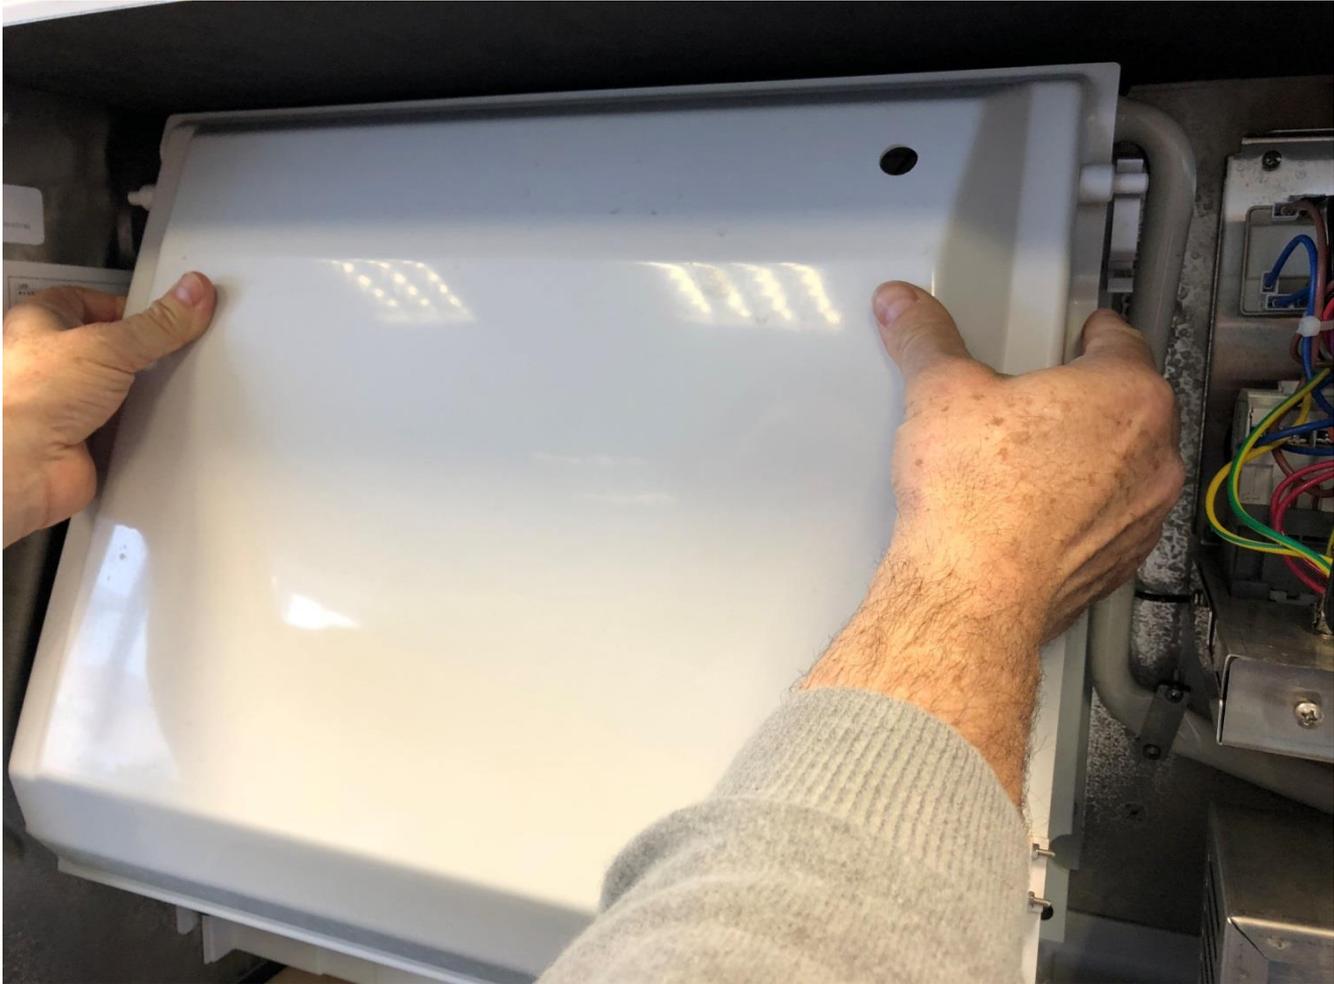
... And the
plastic deflector

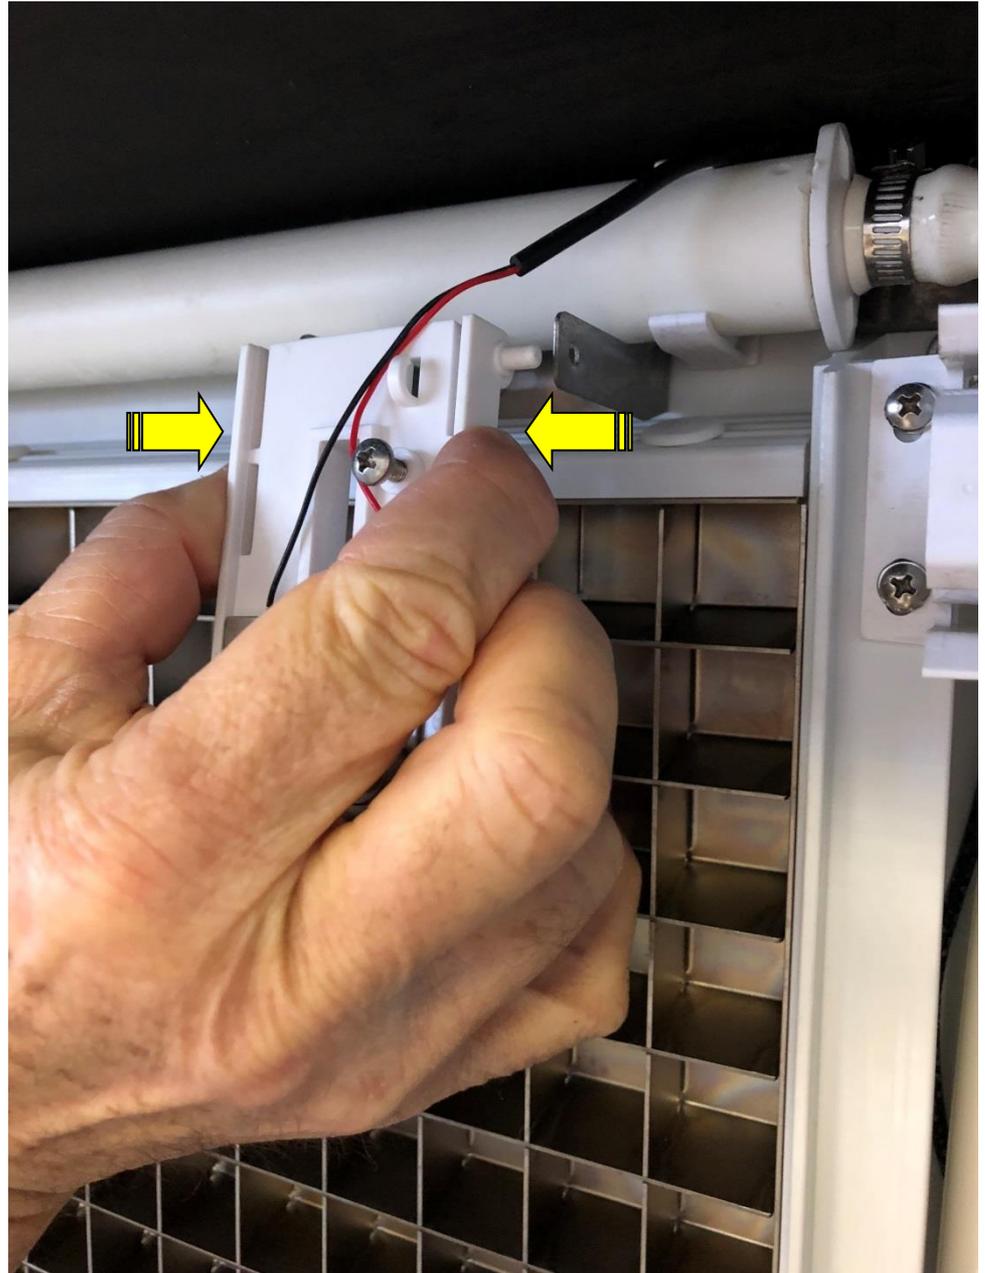
Push the ice
thickness sensor
external plastic
arms and take it off
from its housing

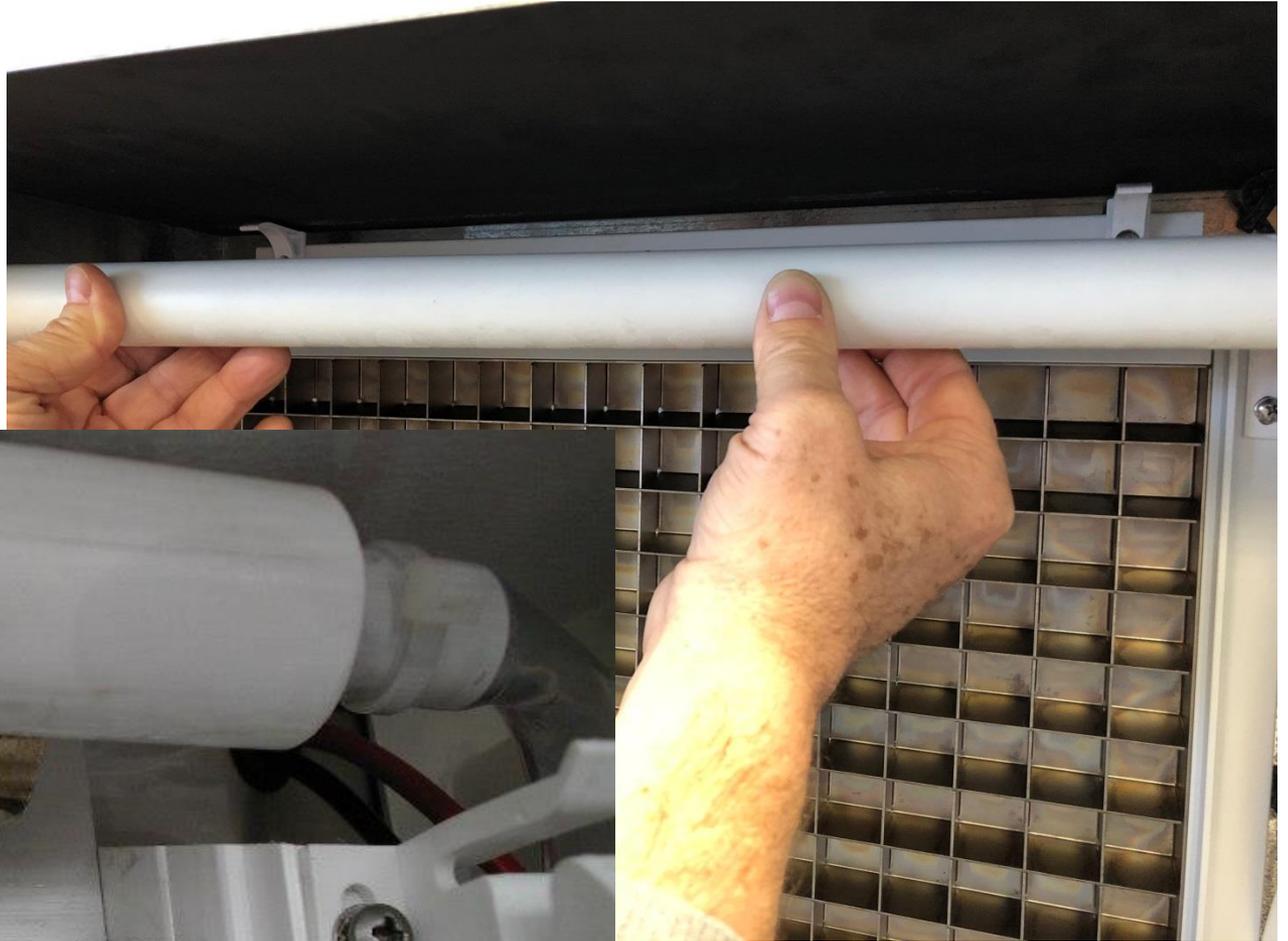
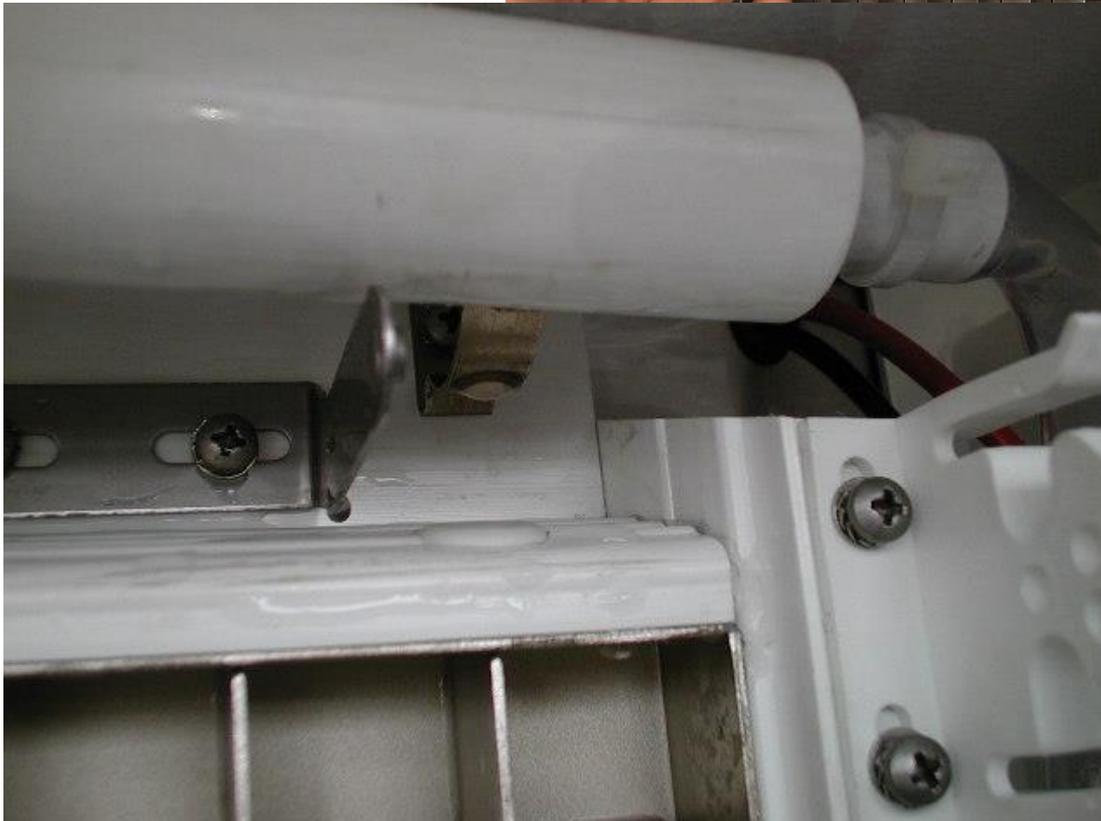
Disconnect the
water inlet
hose from
distributor tube

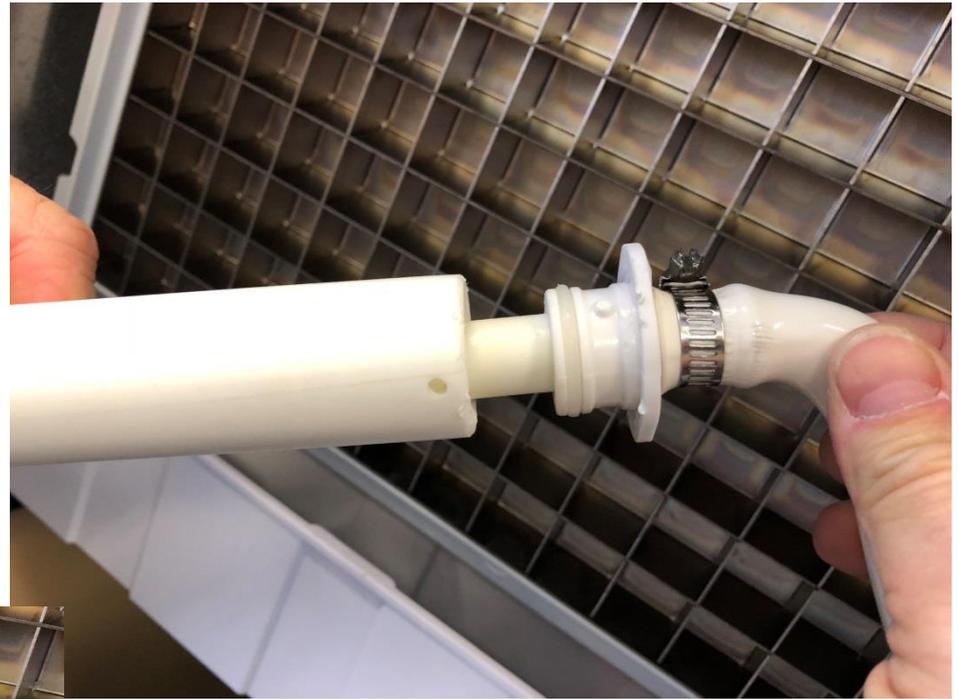
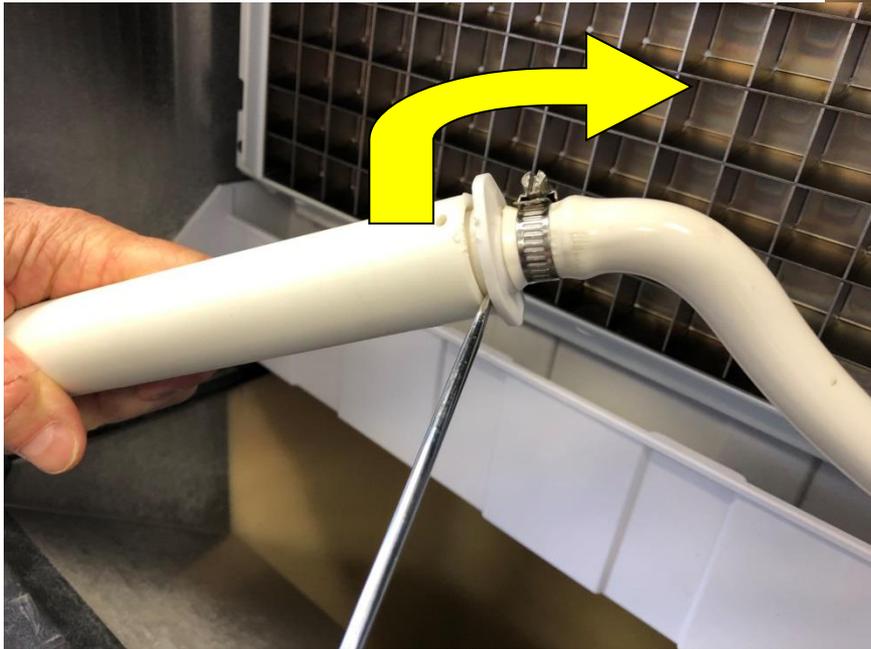
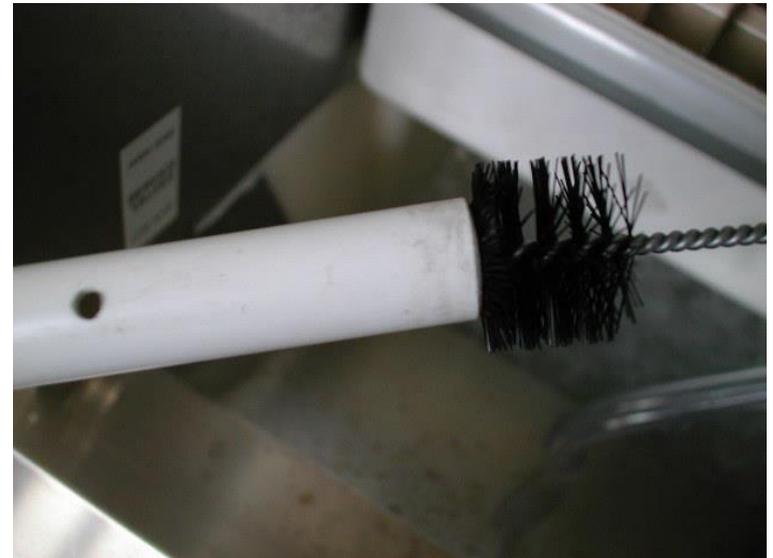
Open up the water distribution tube for cleaning

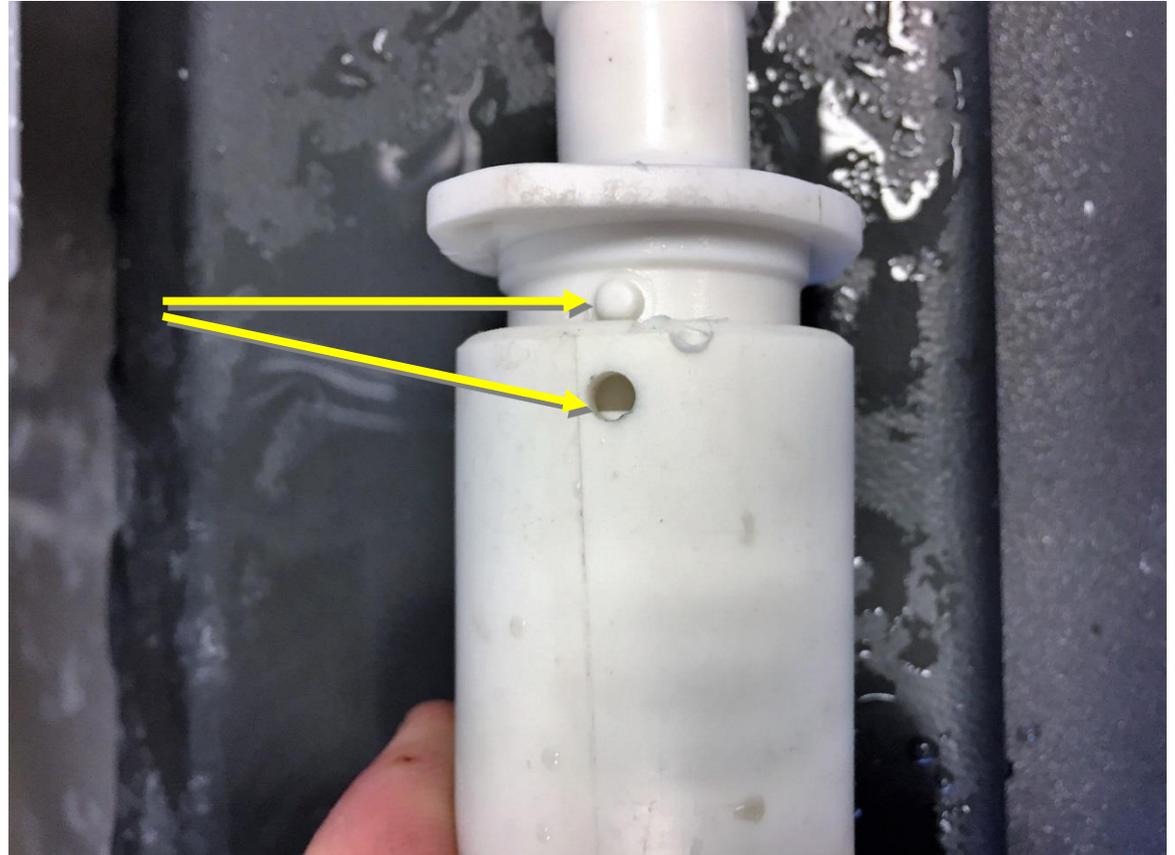
Once properly cleaned re-assembly the Water Distributor Tubes then re-fit it again on the upper side of the evaporator paying attention to match the plastic pin with the hole.

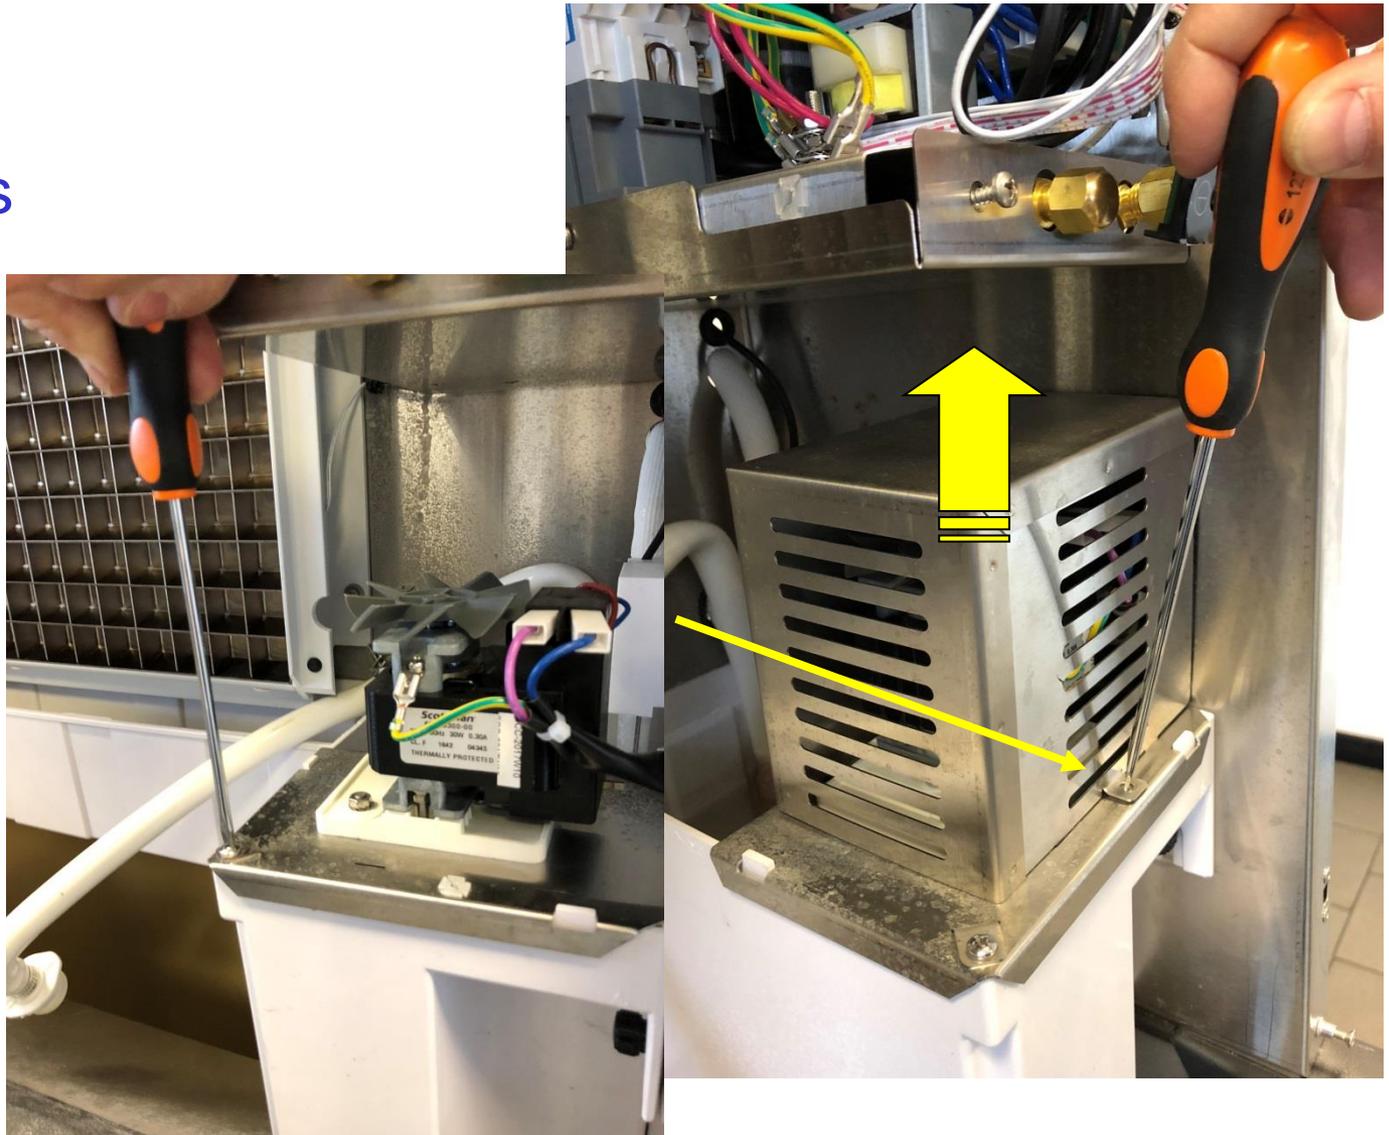
Unscrew
water pump
bracket screws
and remove it
from the
reservoir

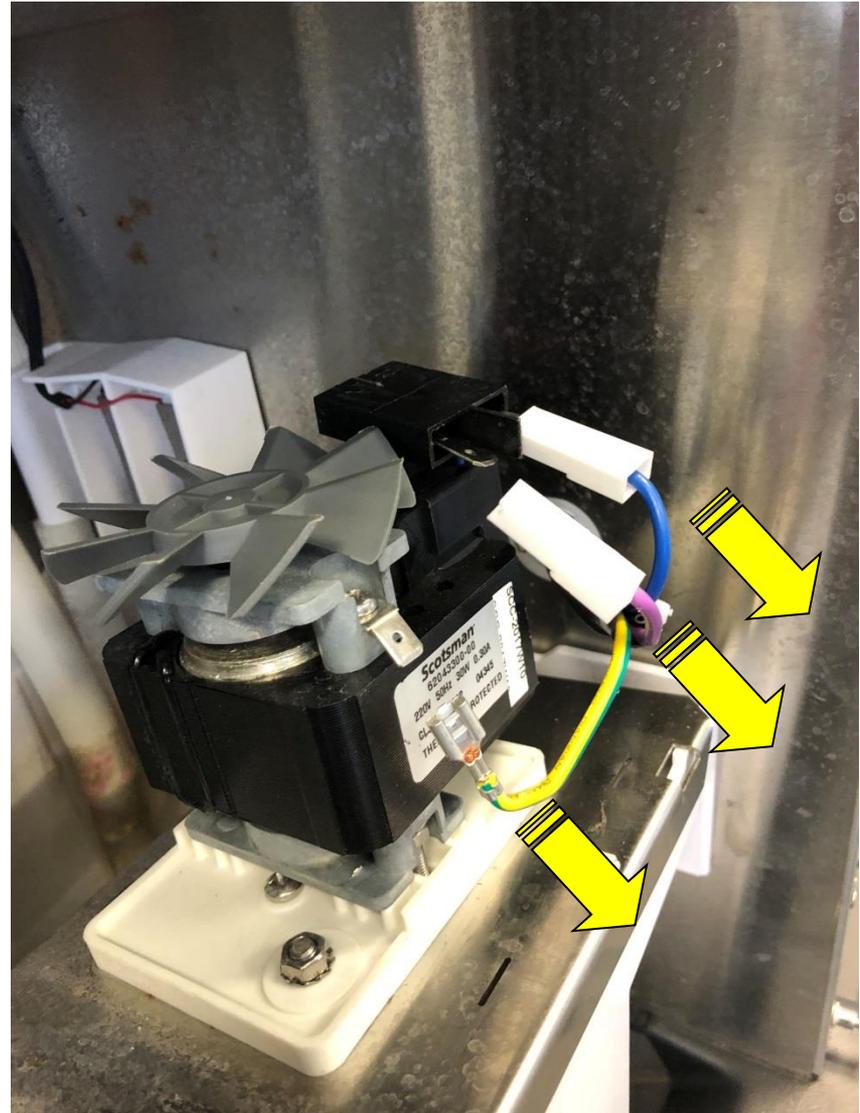
Disconnect the
water pump
from its power
spade
connectors

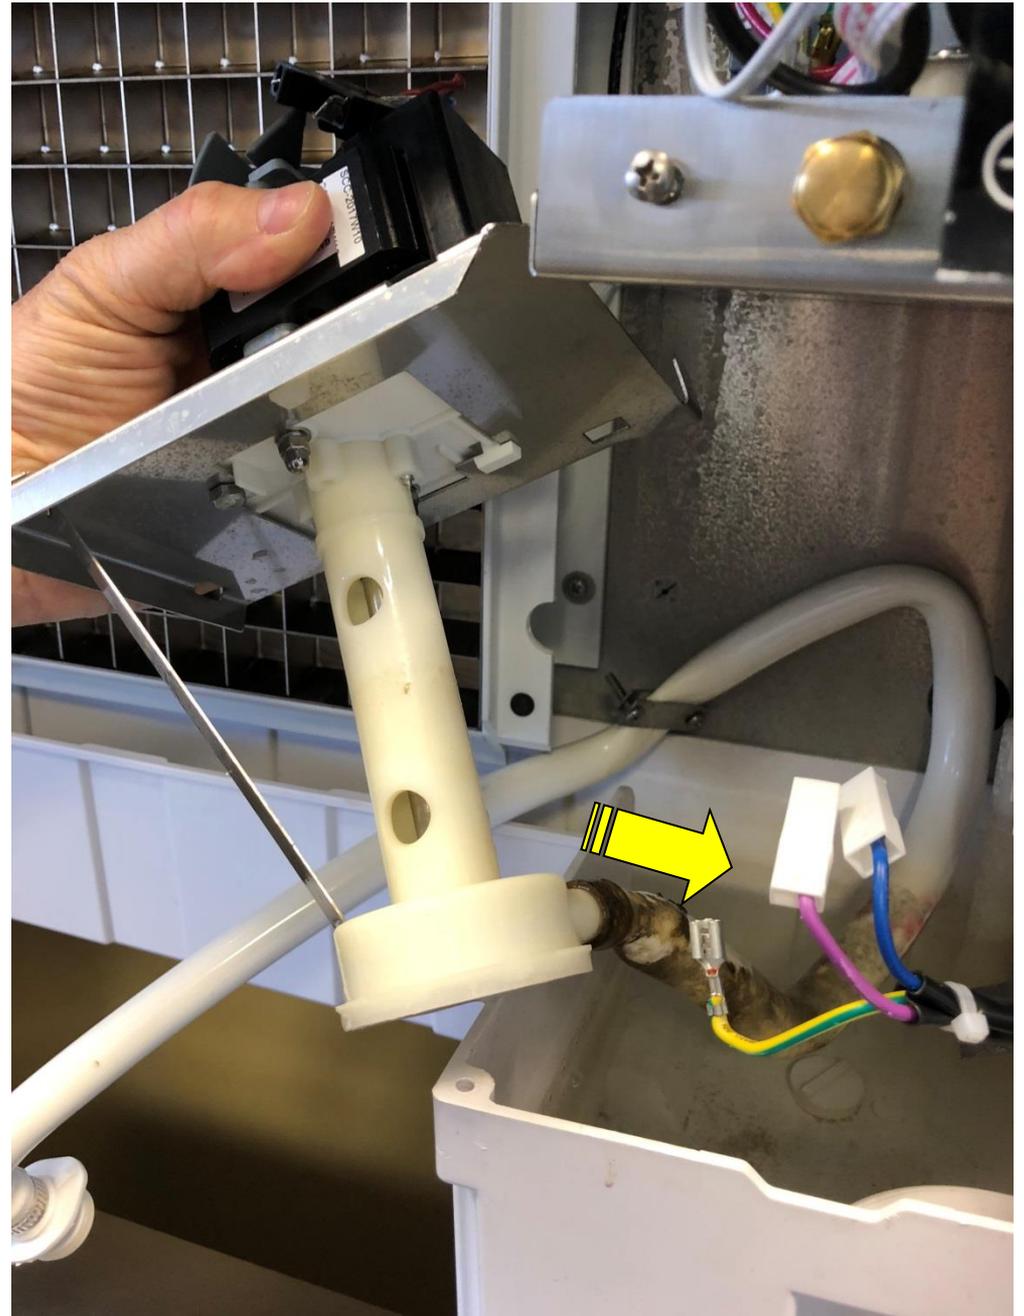
Remove water pumps from the reservoir and disconnect the water discharge hose

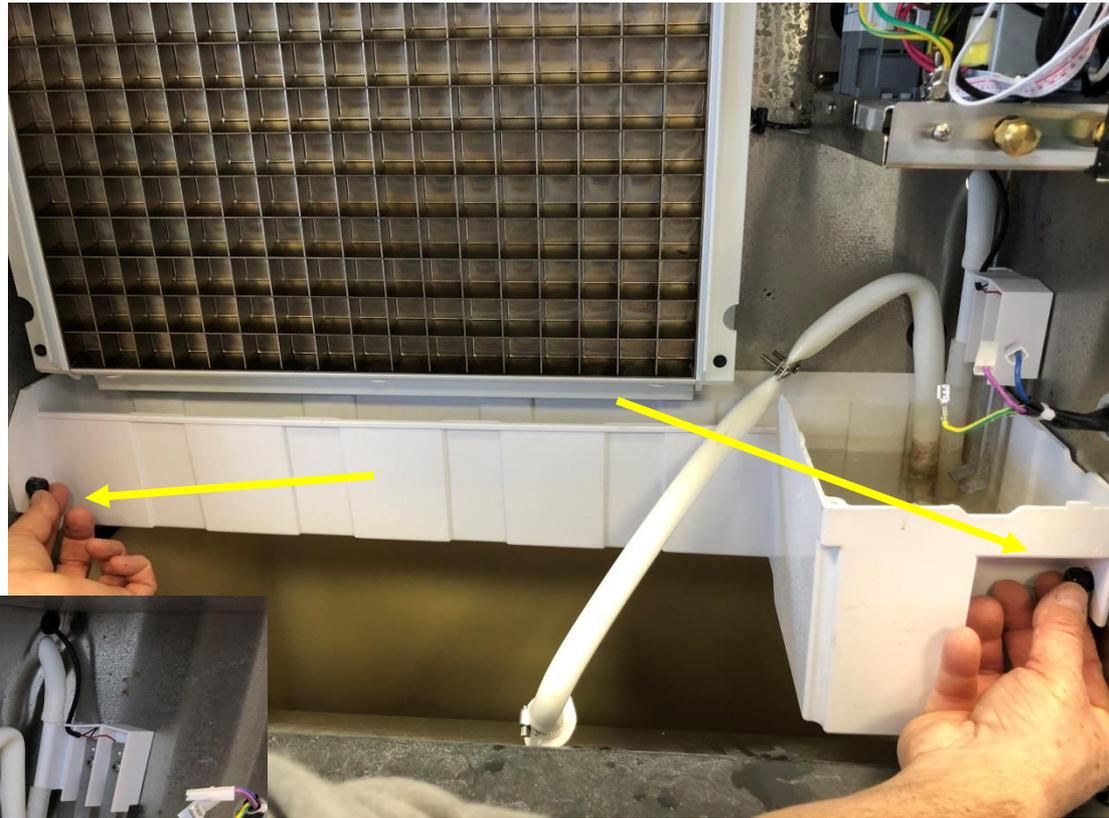
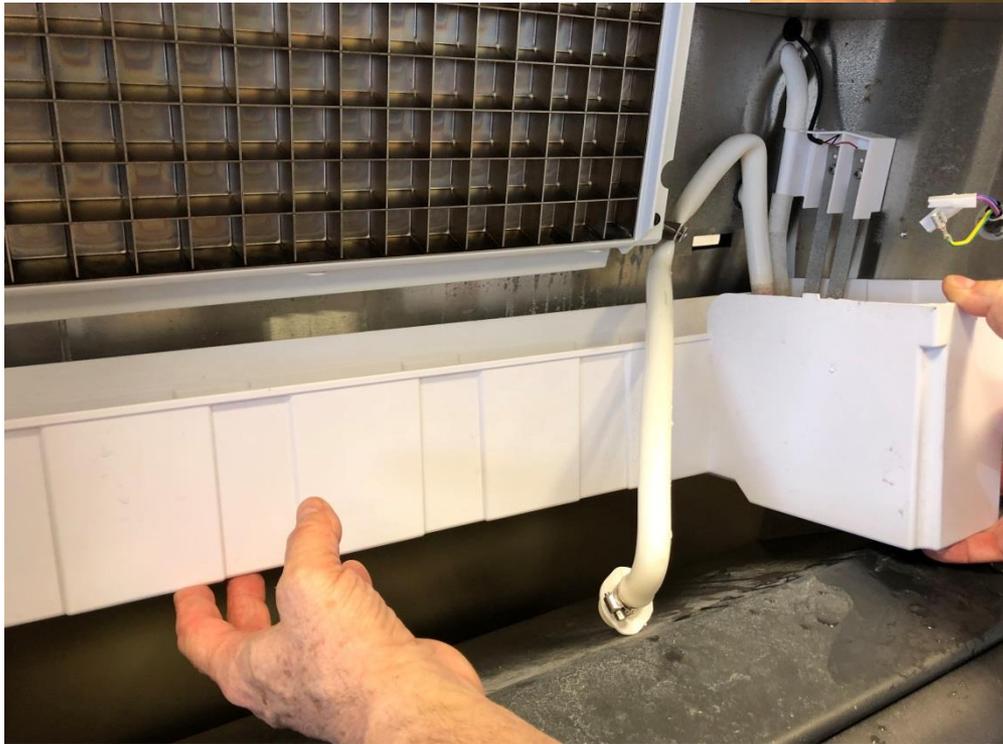
Unscrew the two thumb screws then withdraw reservoir from its seat

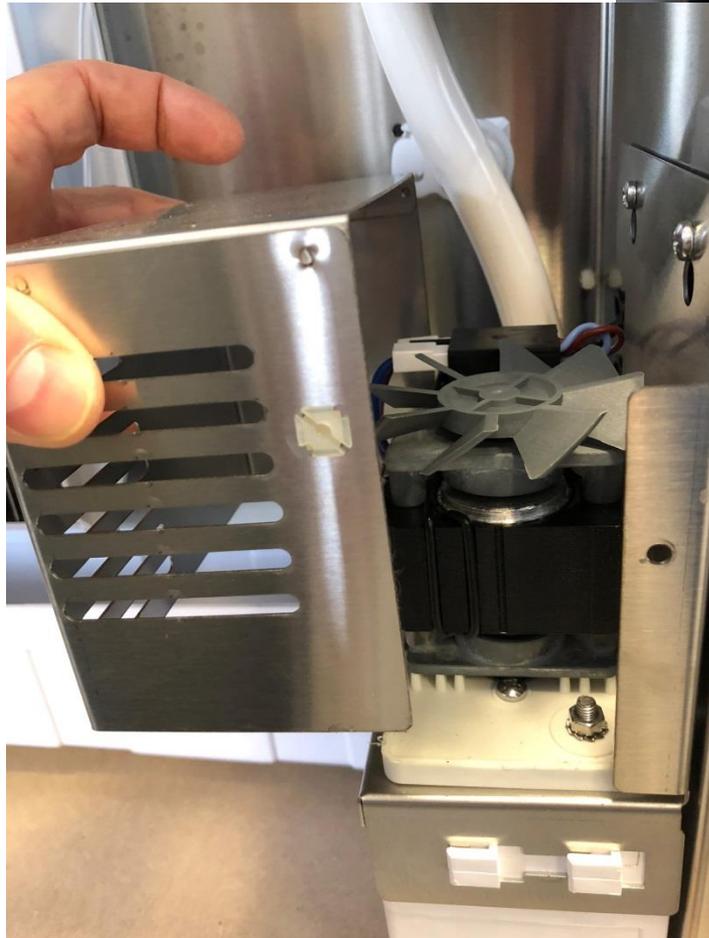
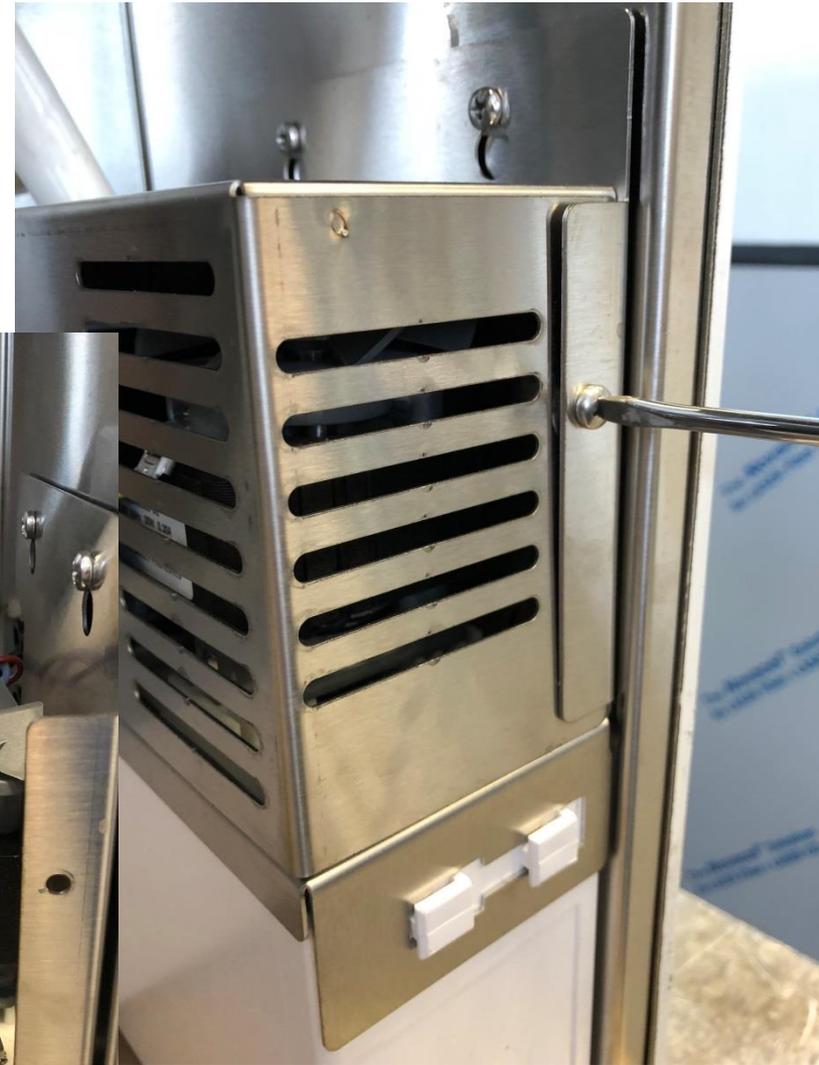
NW 308-508

Unscrew
water pump
bracket screws
and remove it
from the
reservoir

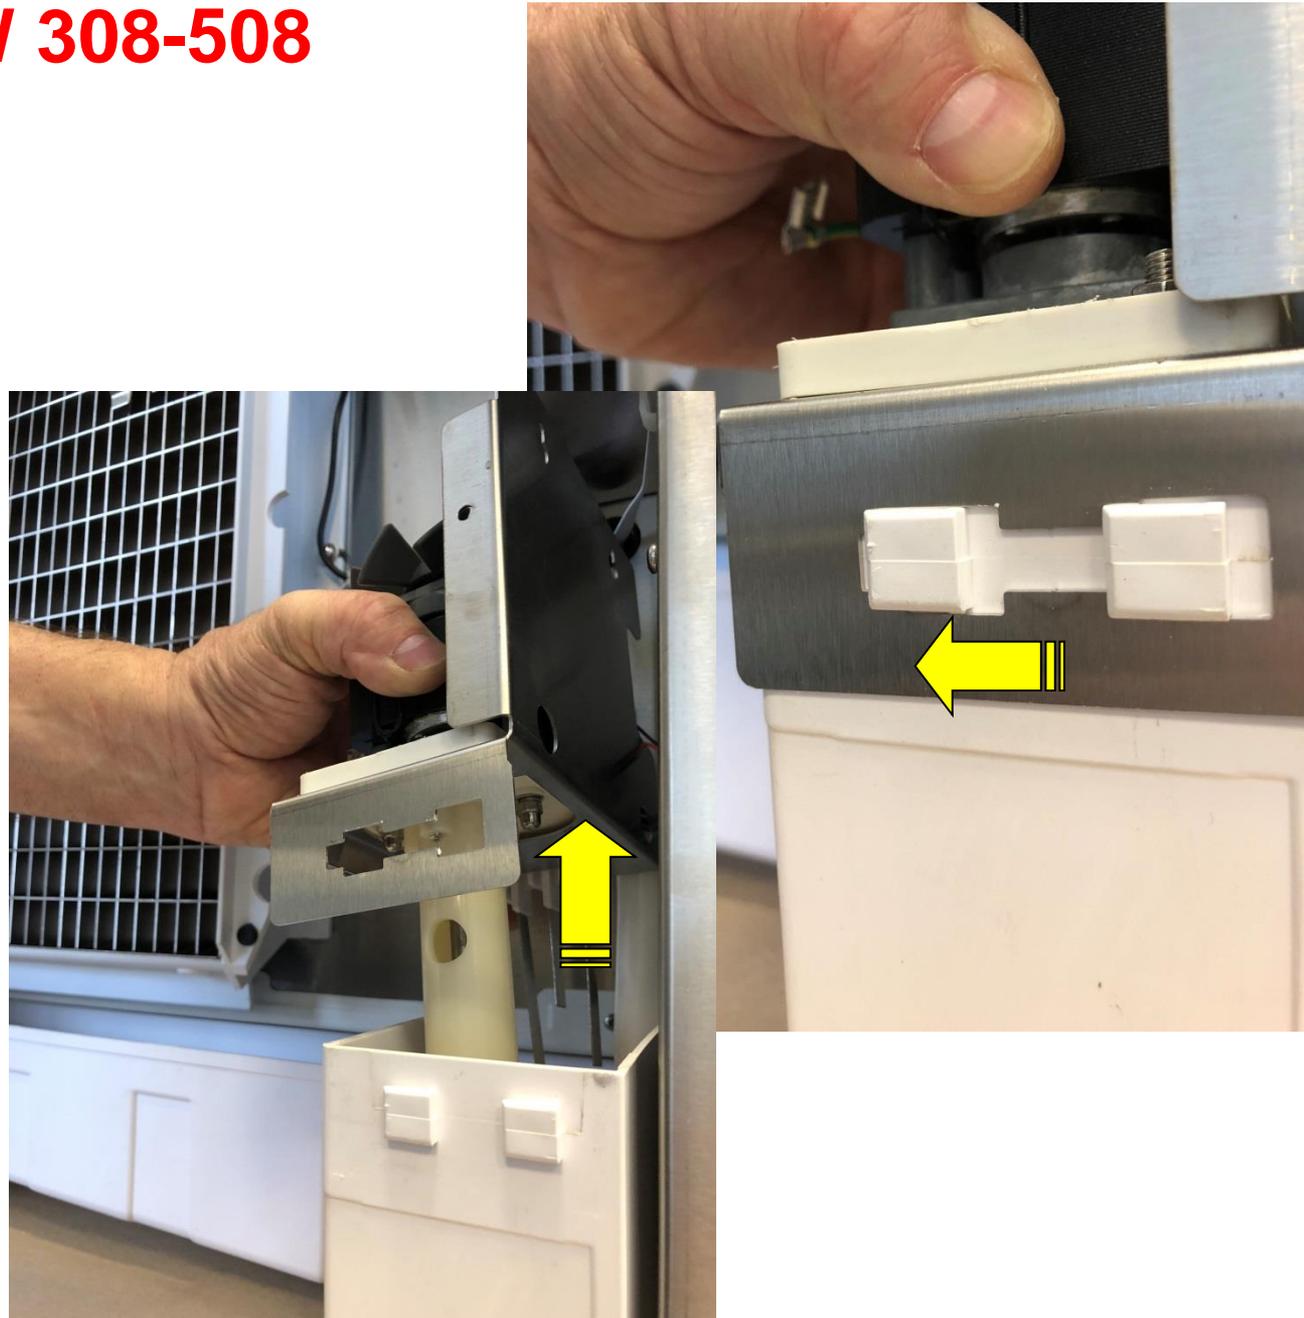
NW 308-508

Slip to the left side the water pump bracket thus to release the same from the water reservoir and lift up the water pump

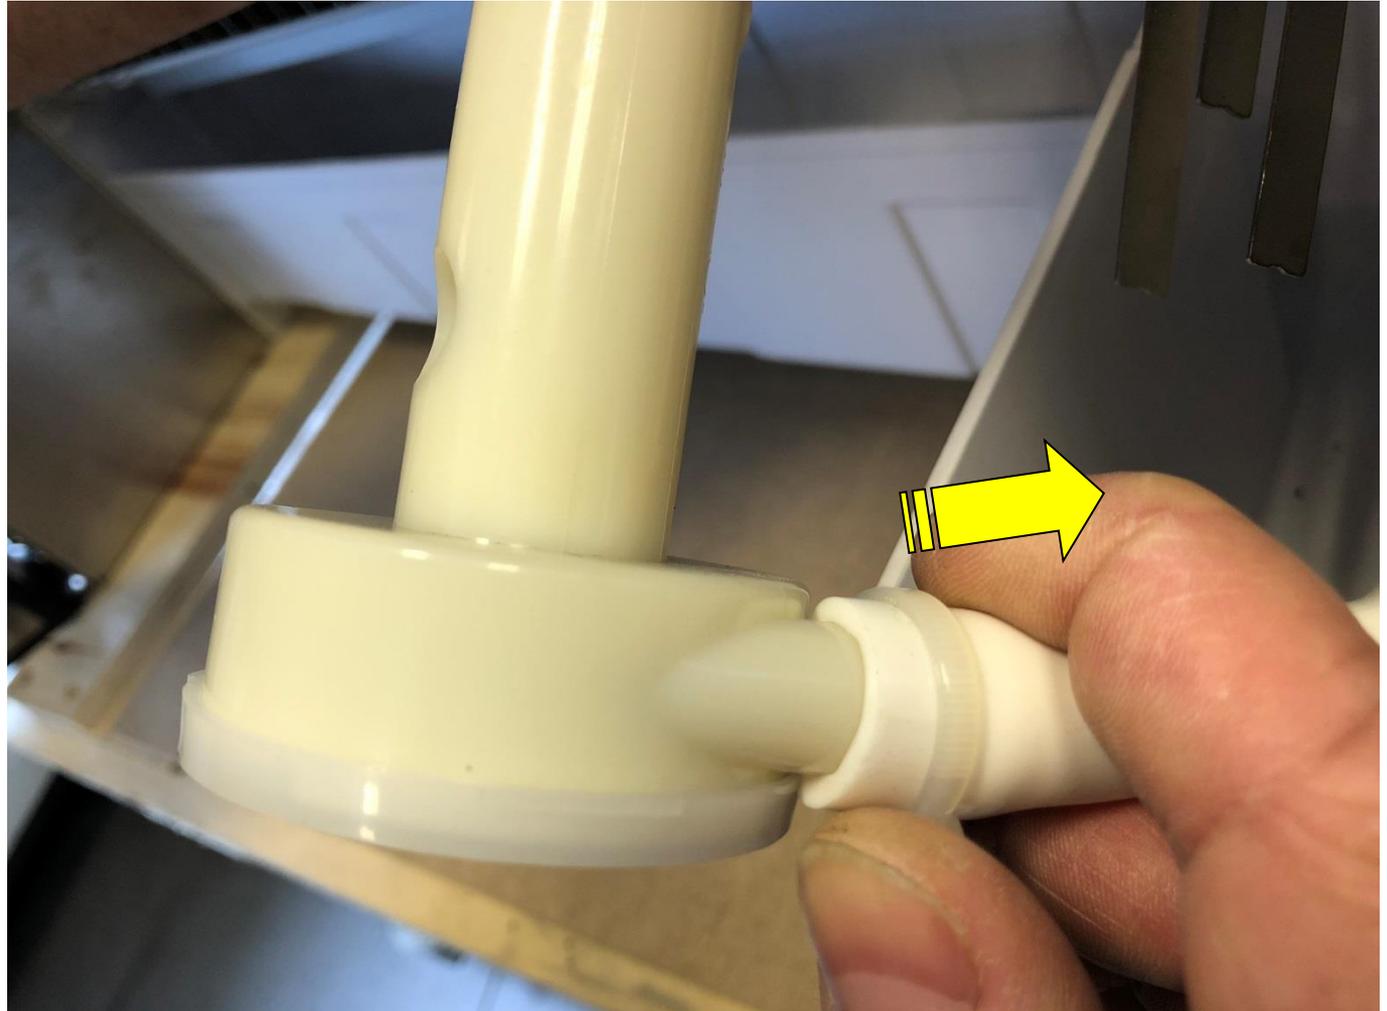
NW 308-508

disconnect
the water
water
discharge
hose

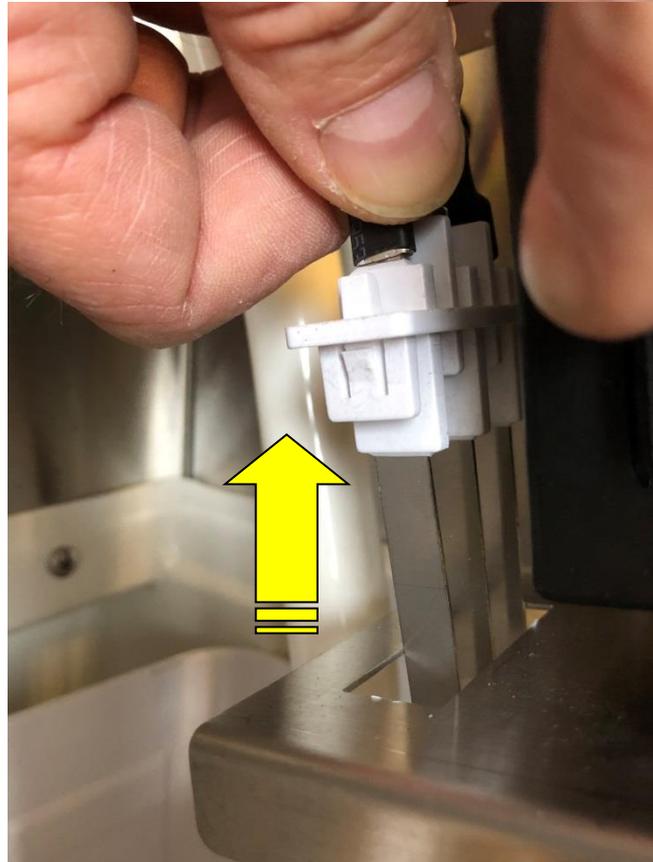
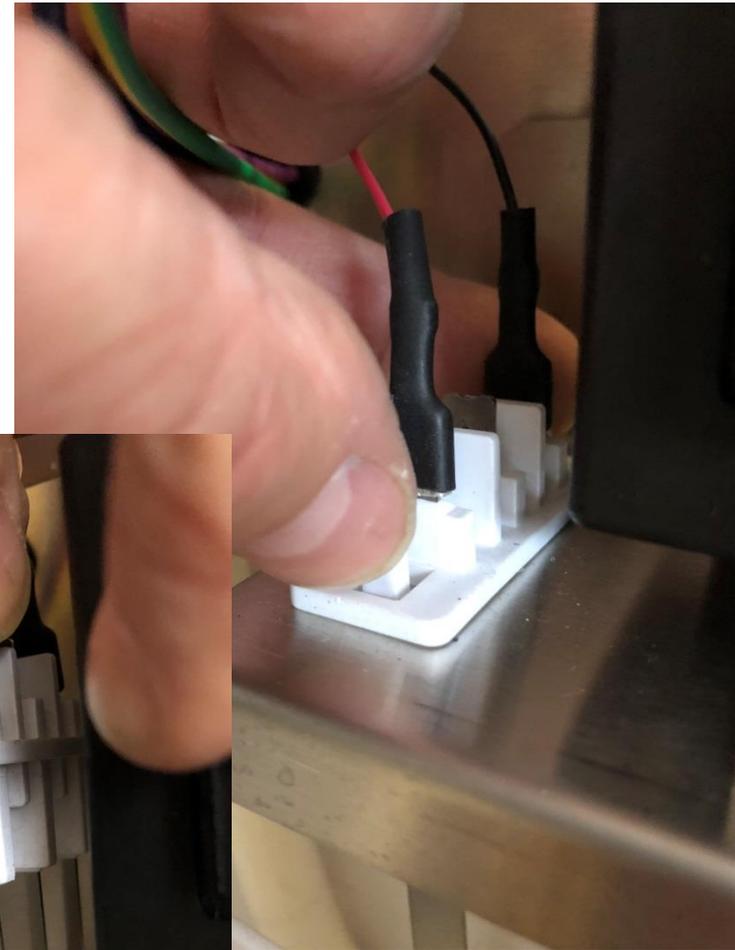
NW 308-508

Push the water level
sensor arms IN and
remove the same
from its seat

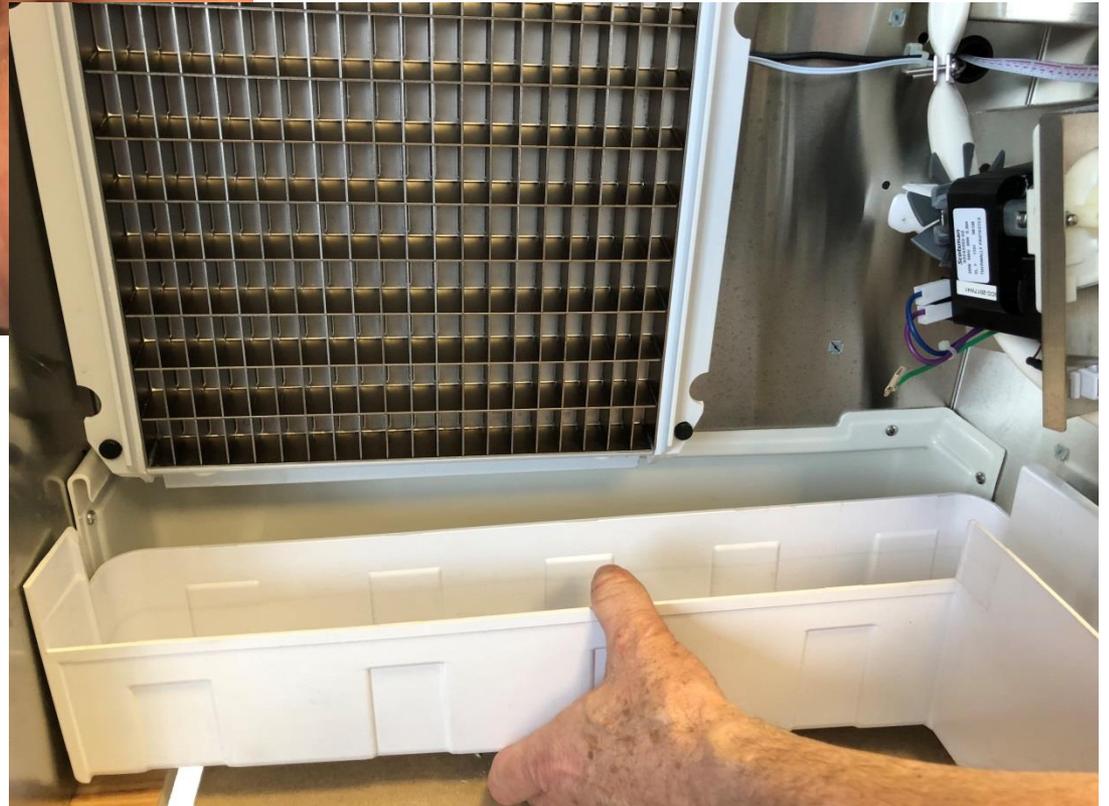
Hang on water reservoir
left holding bracket and
withdraw reservoir from its
seat

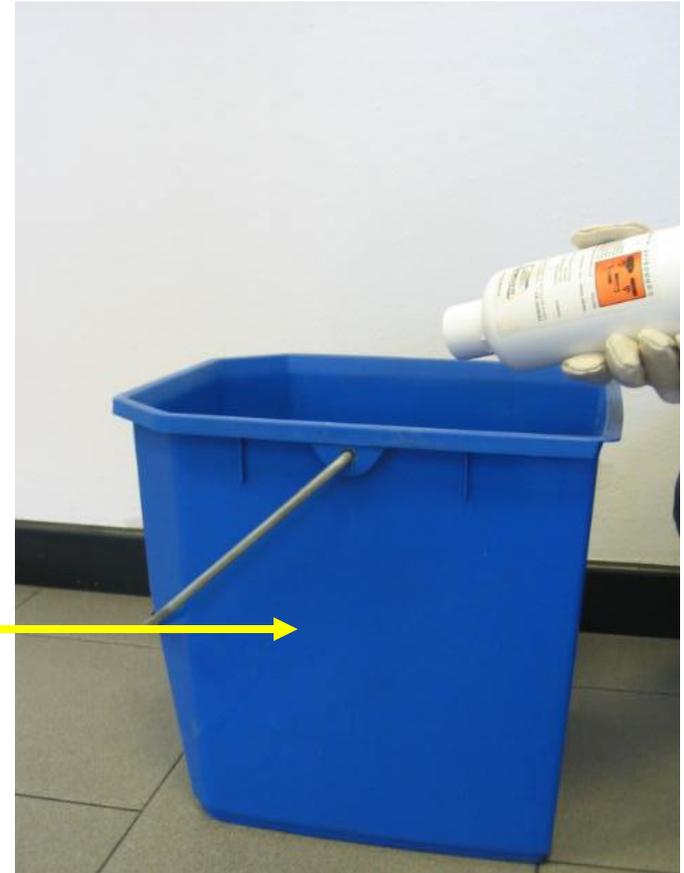
Prepare the cleaning solution by diluting in a plastic bucket two liters of lukewarm water (max 40°C) with 200 ml of **SCOTSMAN Ice Machine Cleaner**.
