**SECOND
HALF**

MAINTENANCE

The most important program on the maintenance of the cubers machines is the cleaning/sanitizing to be done on regular base as detailed here below

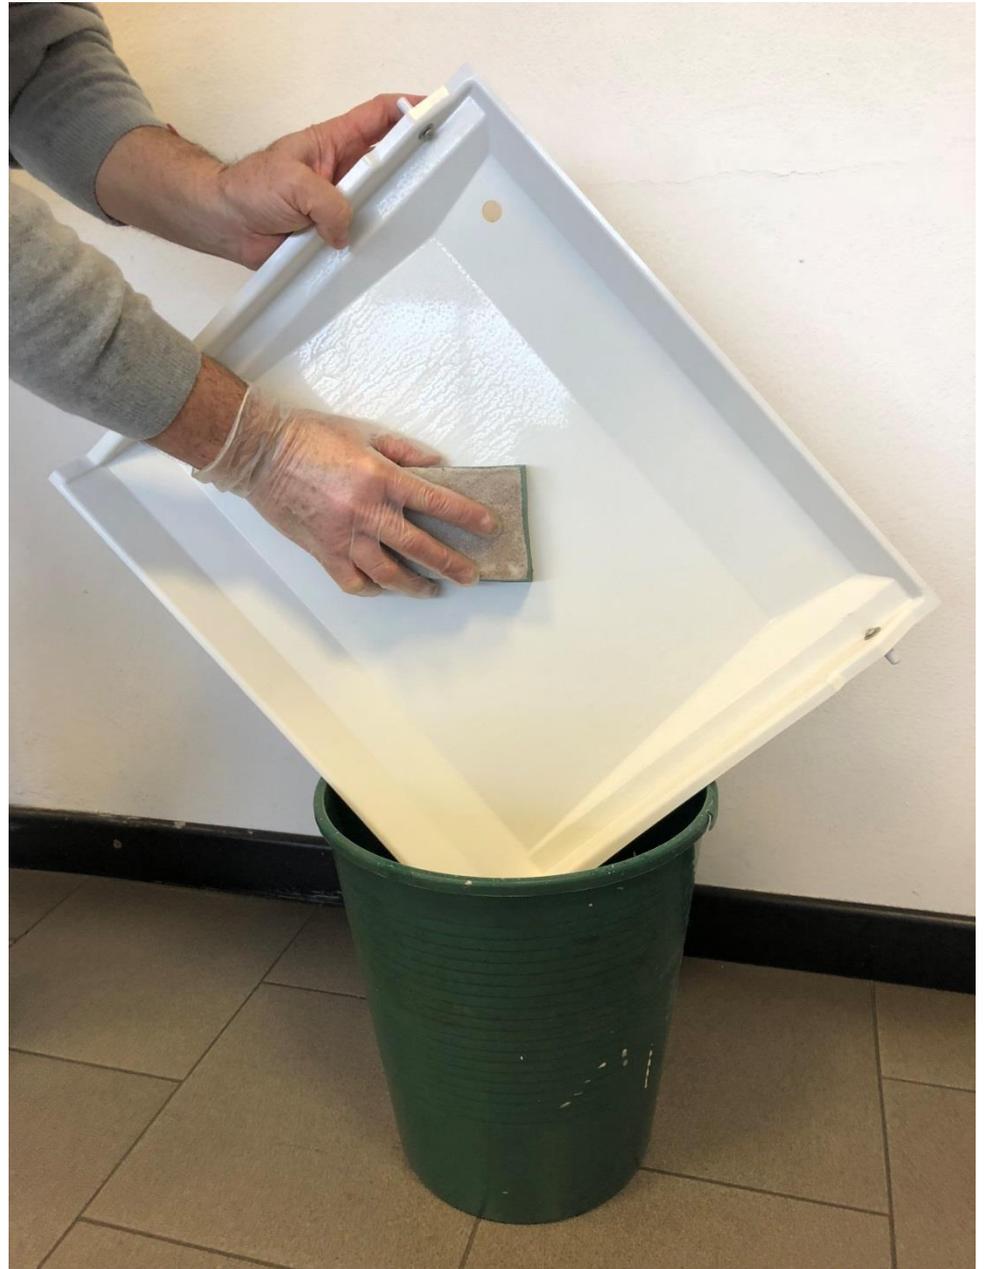
Clean evaporator
plastic cover by
cleaning solution
then rinse it by fresh
water

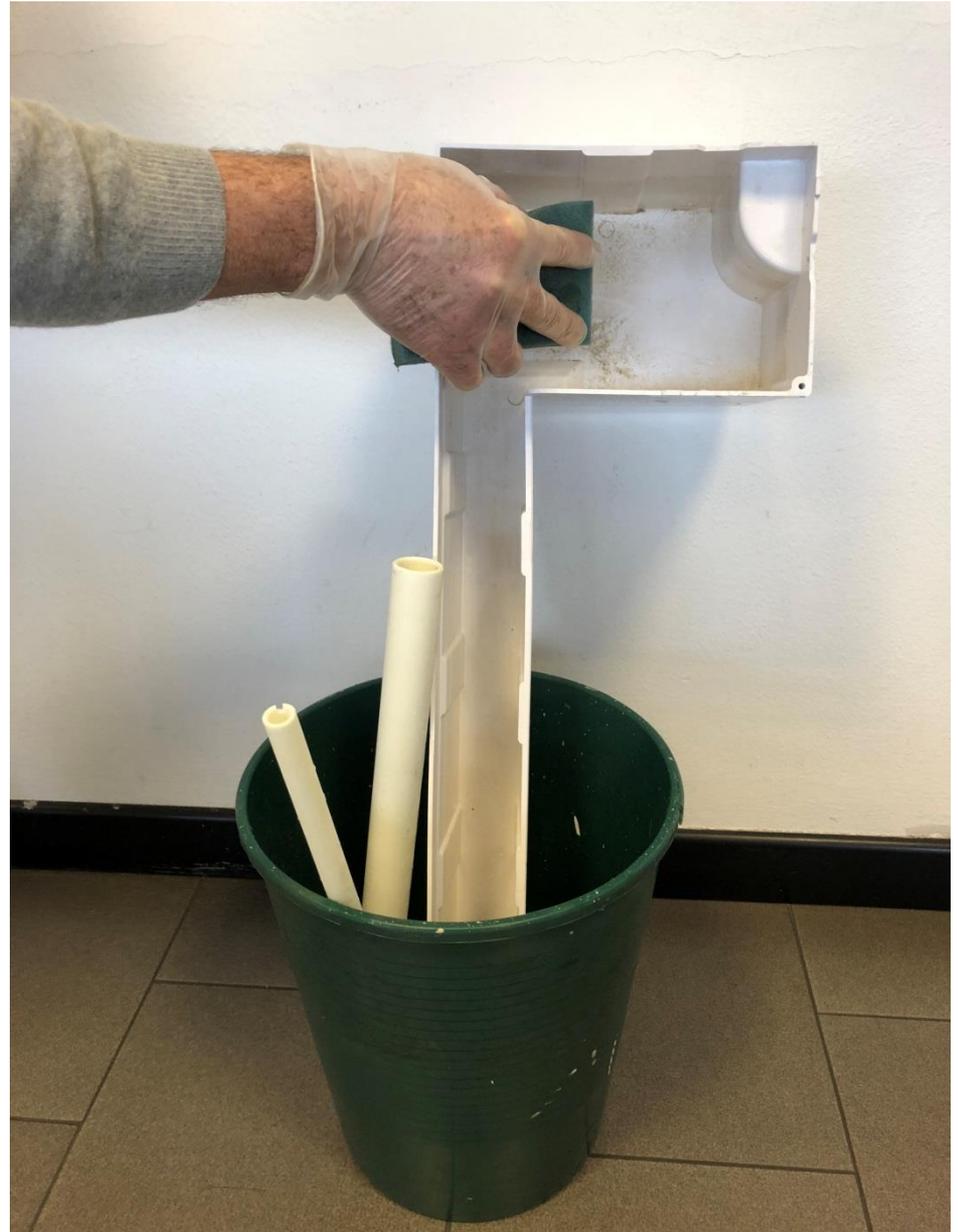
Clean water
distribution
tubes and water
reservoir by
cleaning
solution then
rinse it by fresh
water

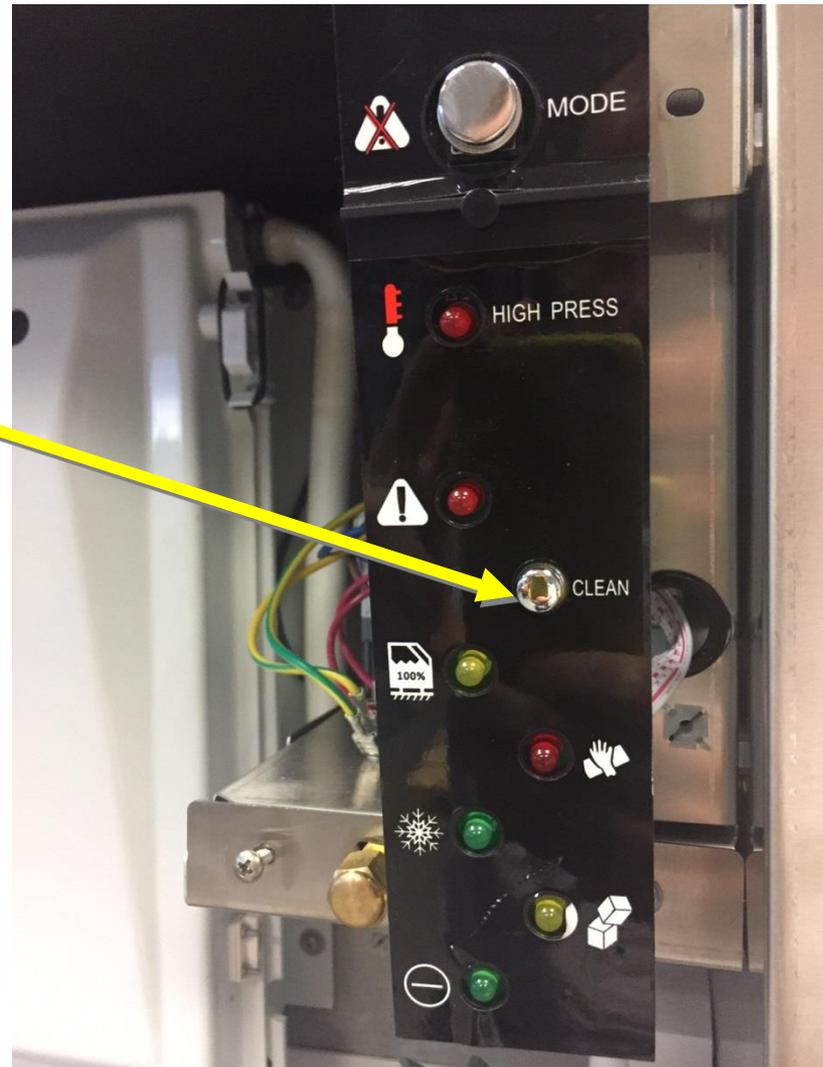
Push the
CLEAN
BUTTON for
2-3 seconds

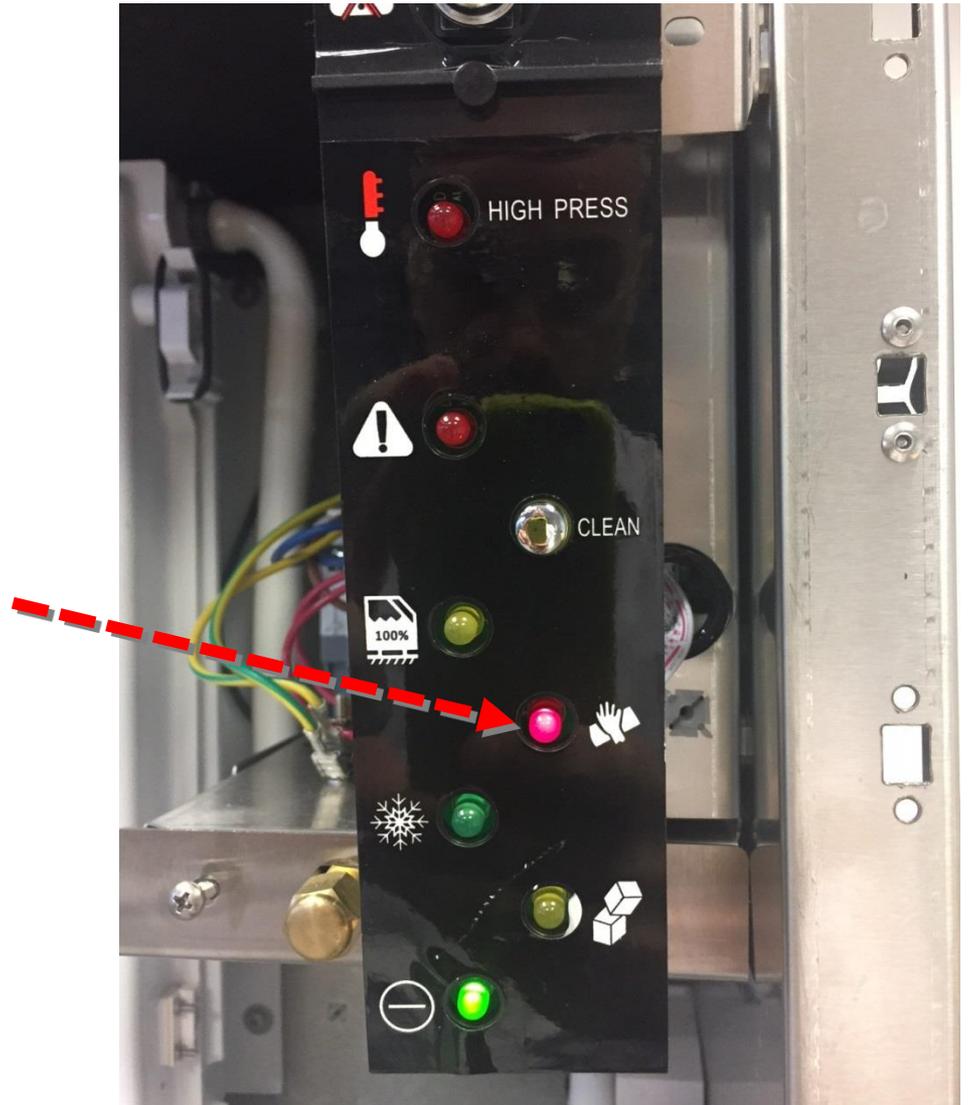
The machine enters in the Cleaning/Sanitize cycle with the red CLEAN LED light on MONITOR PANEL blinking fast in whole procedure

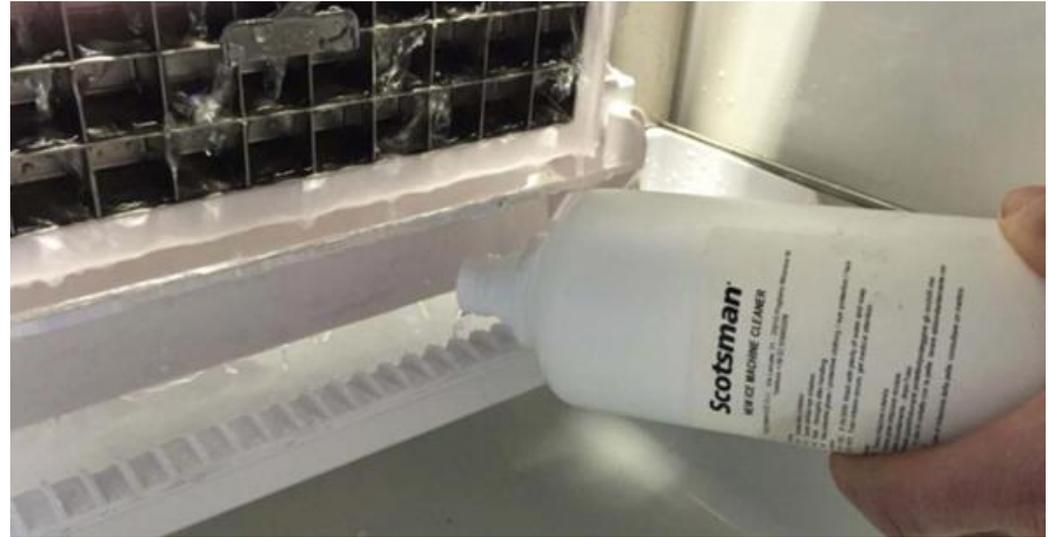
In the first 30 seconds of clean procedure the machine purge water from the sump, then pour:

NW 308: 180 ml

NW 506: 200 ml

NW 458-608: 350 ml

NW 1008: 350 ml

of SCOTSMAN cleaner inside water sump while...

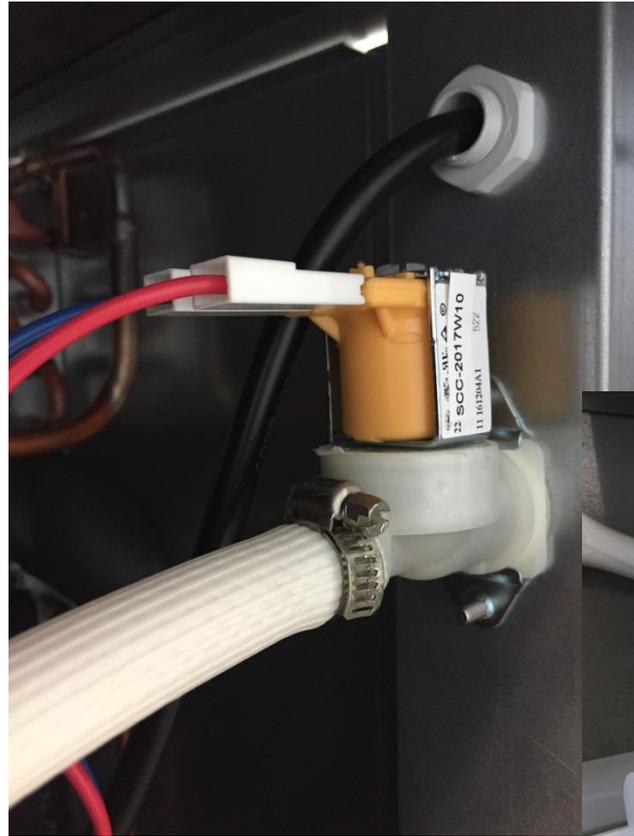
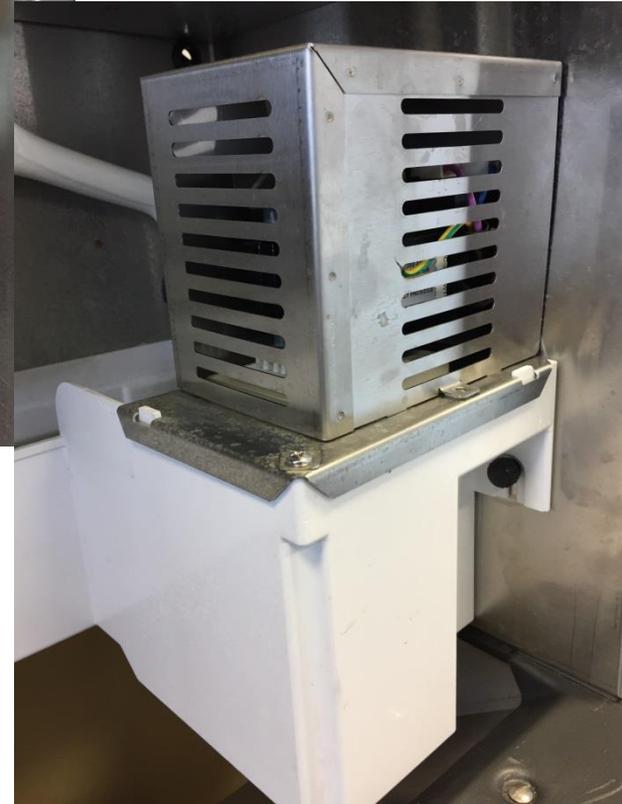
.....the water inlet valve will be energized till the fill up of the water sump . The water pump starts to operate

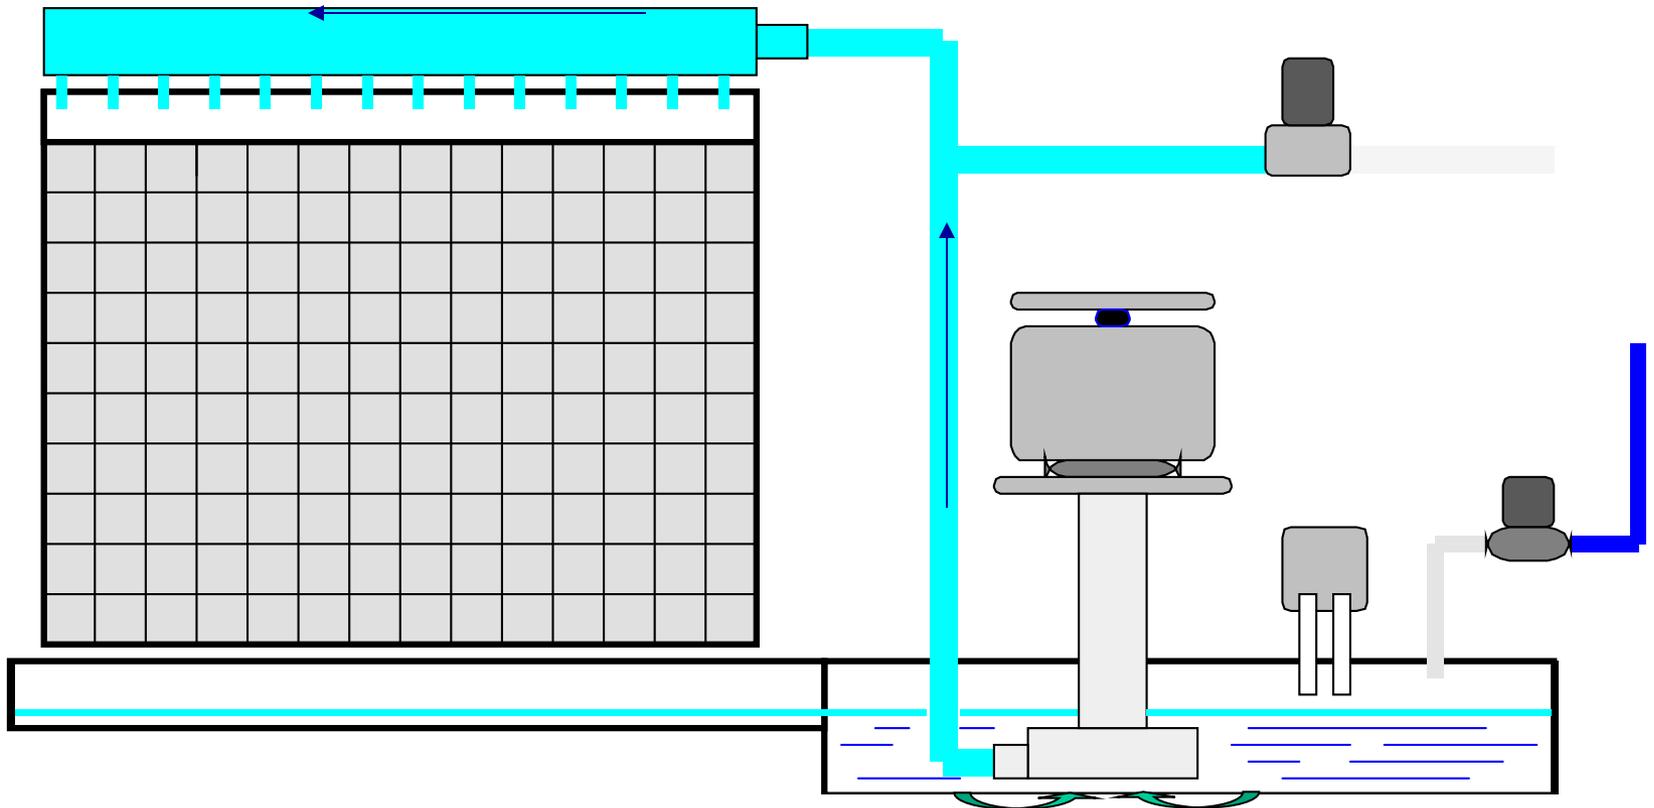
With the system in Cleaning mode the water pump is the only component in operation to circulate the cleaning solution in the entire water system.

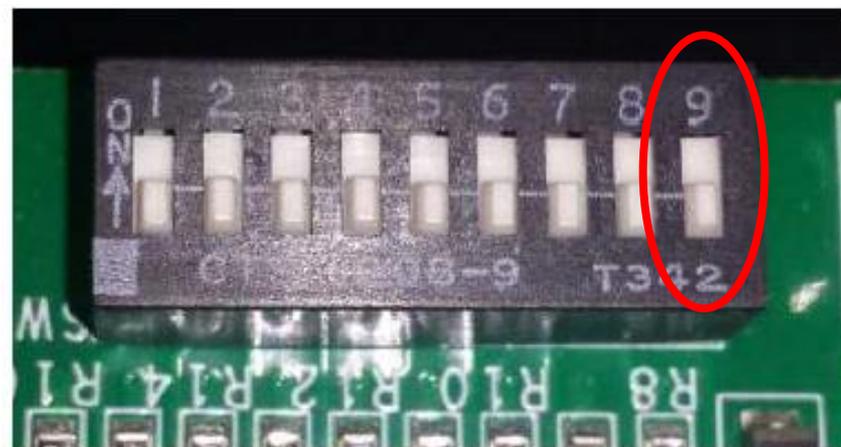
At the end of 10th rinsing cycle, the machine restart according with the setting of DIP-SWITCH n.9

OFF = Machine will stop clean procedure with slow blinking of Red CLEAN light

Push CLEAN button to restart in freezing cycle

ON = Machine will restart automatically with a new freezing cycle

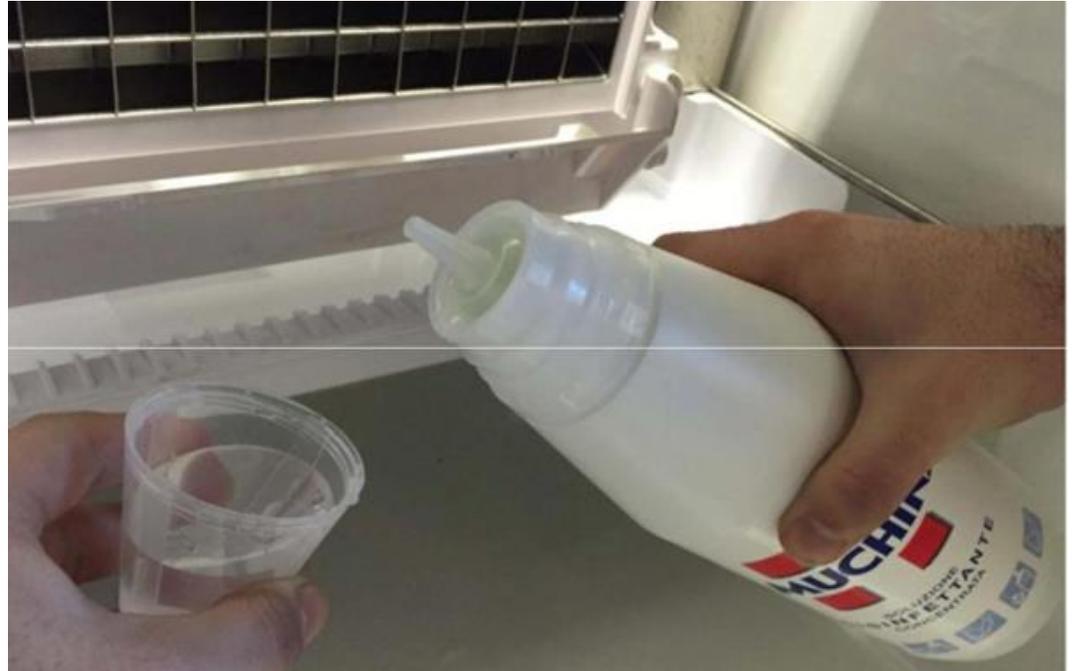
Repeat same
procedure pouring
approx. 5 ml of
Sanitizer
(Amuchina) directly
into the water
reservoir

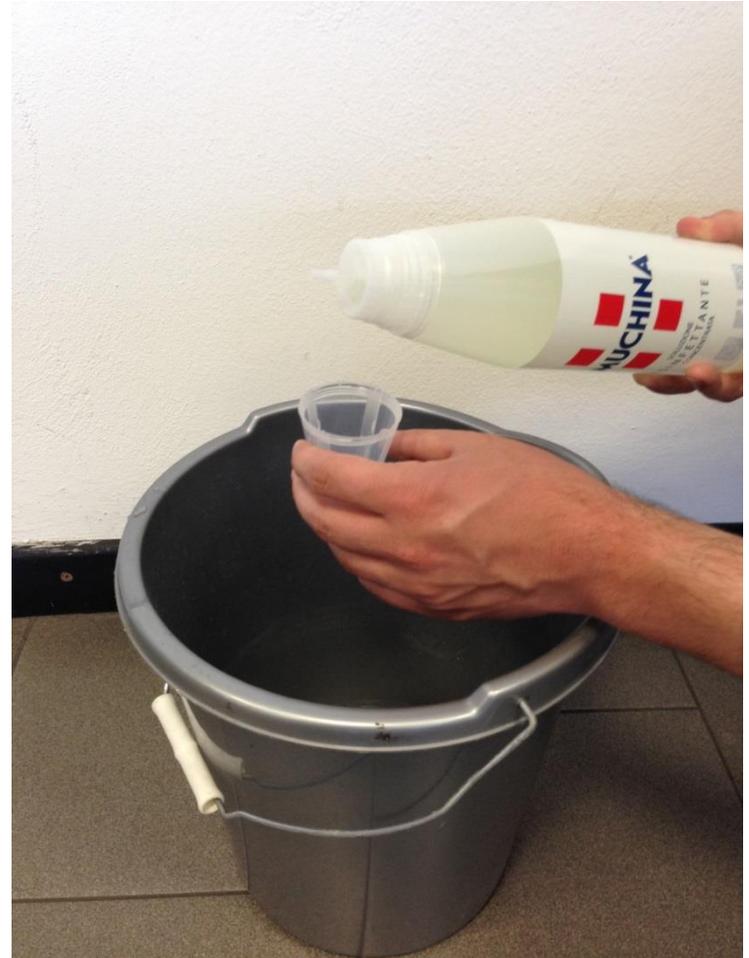
Meanwhile the unit is running the rinsing cycle , mix in a clean bucket some fresh water with 1% of sanitizer product (Amuchina)

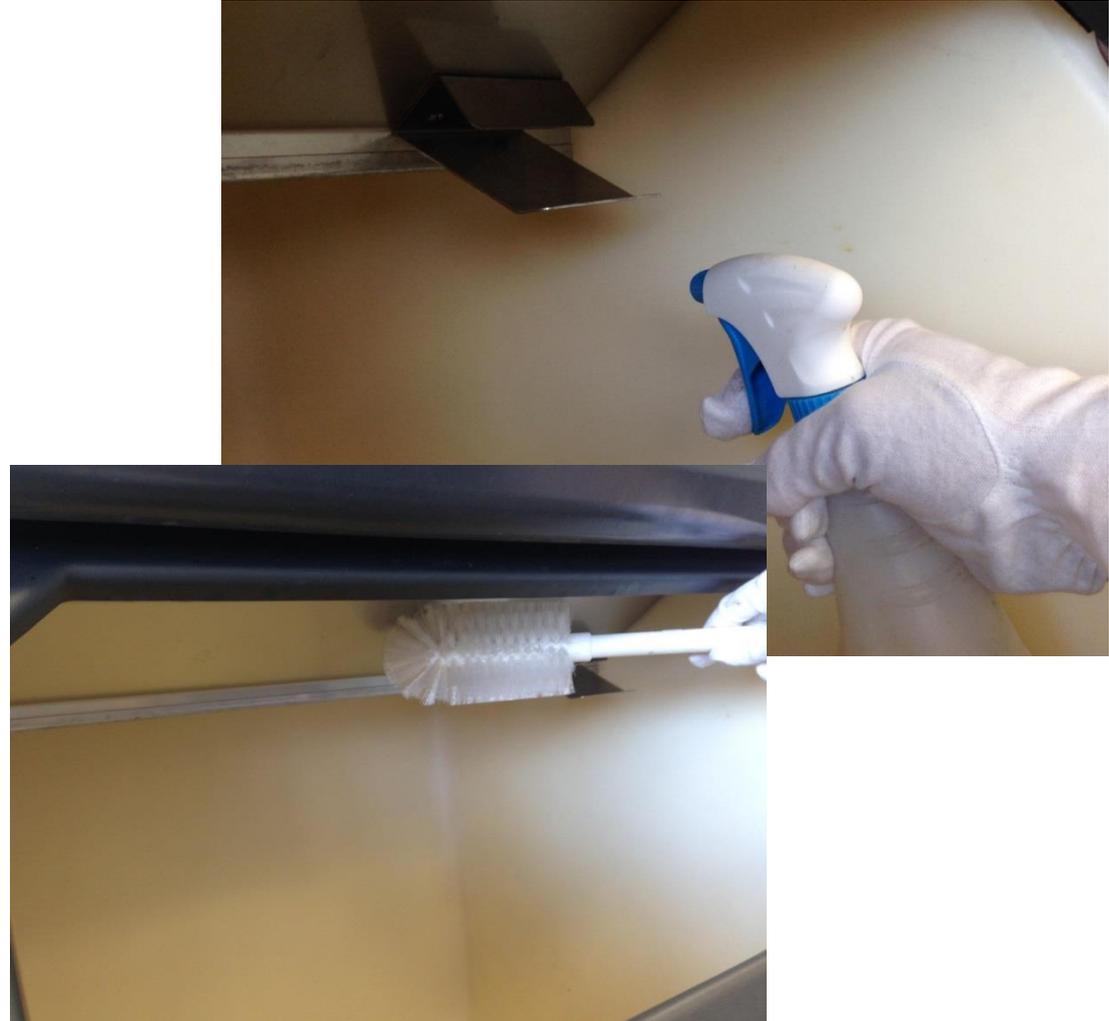
Fill up with the mixed solution a spray bottle, then spray the same to all bin internal wall/area and wipe with a proper brush the SS deflector as well as the internal surface of the plastic door and the internal area of the bin

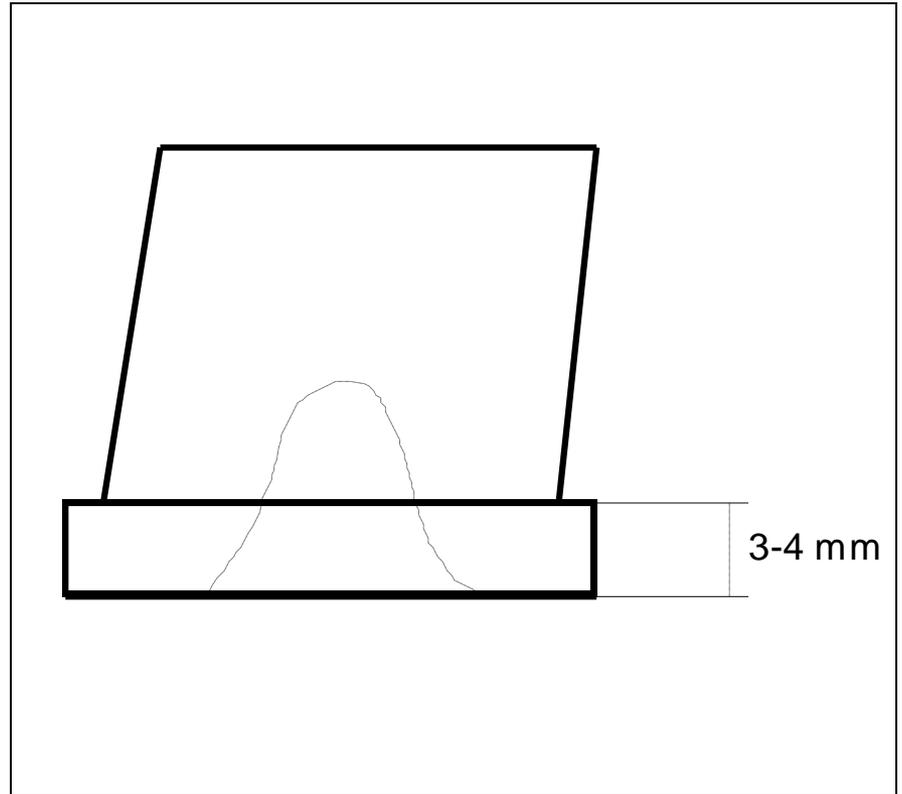
This is a **Scotsman Dice**

Cube.

It must be clear, solid with a bottom rim of about 3-4 mm and a small depression of 9-10 mm.

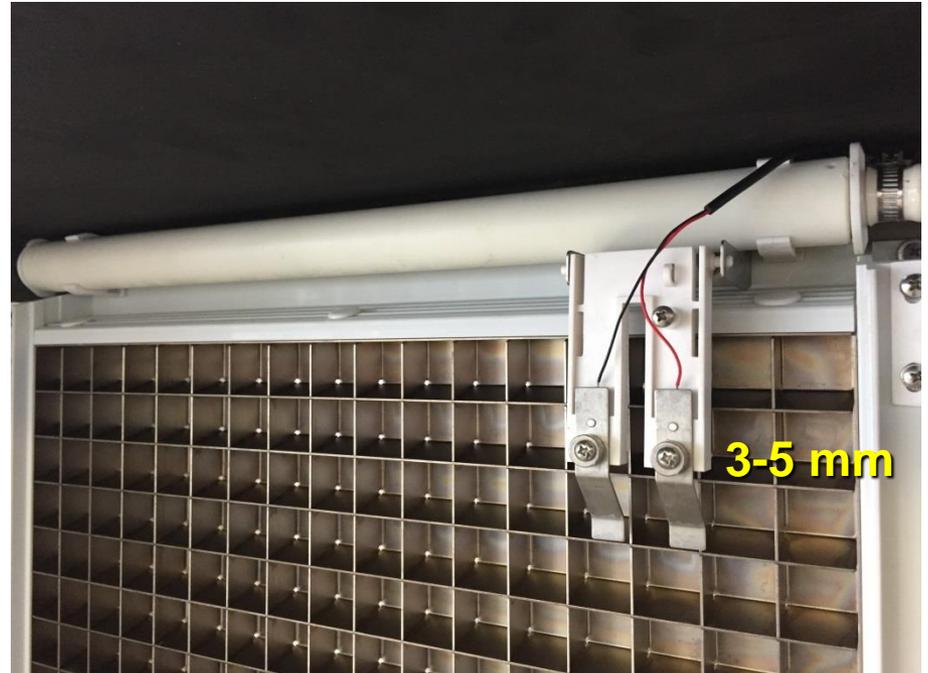
The Ice Thickness Sensor must be adjusted so to have a clearance of approximately 3-5 mm between the bottom of the two metal plates and the front of the evaporator cells.

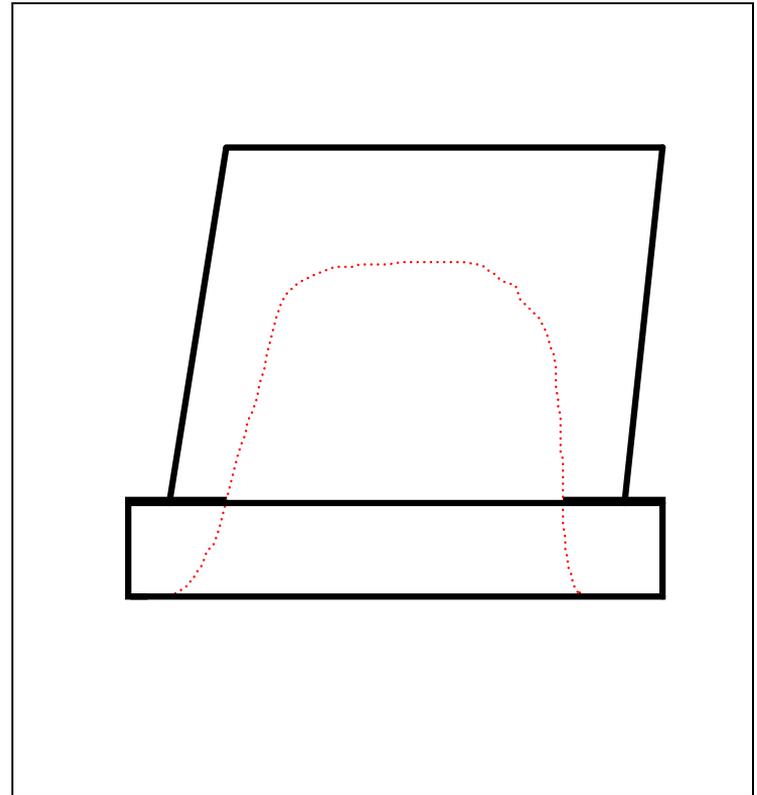
This ice cube is clear, solid but it has a deep depression on its bottom rim due to a too short freezing cycle.

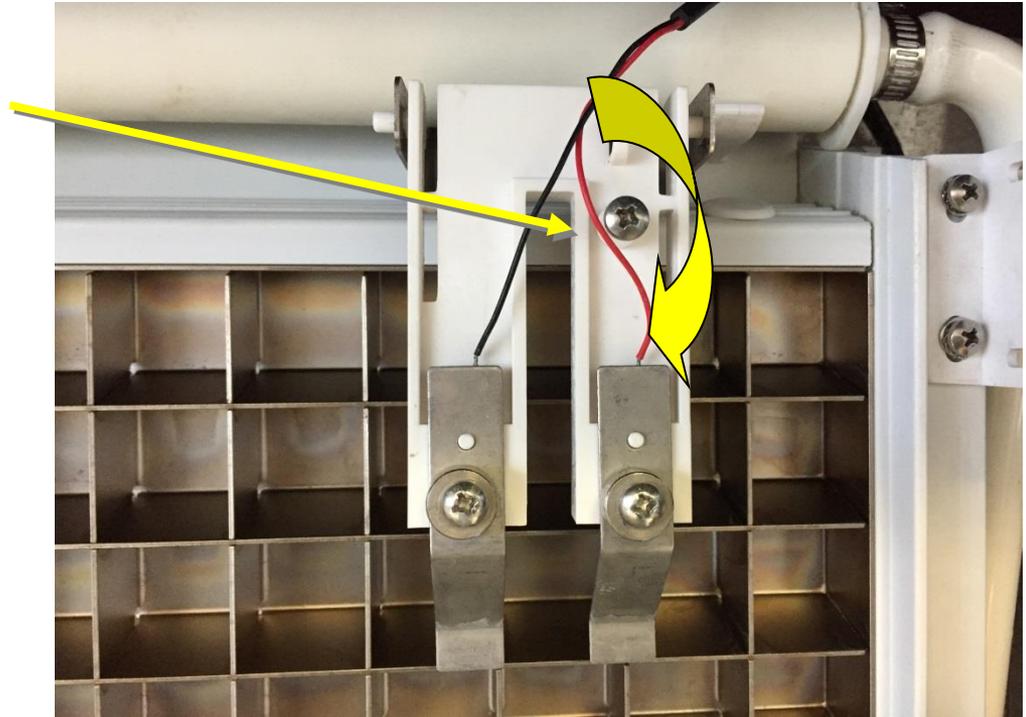
It is necessary to extend the length of the freezing cycle by adjusting the clearance between the ice thickness sensor and the front of the evaporator turning the adjusting screw clockwise.

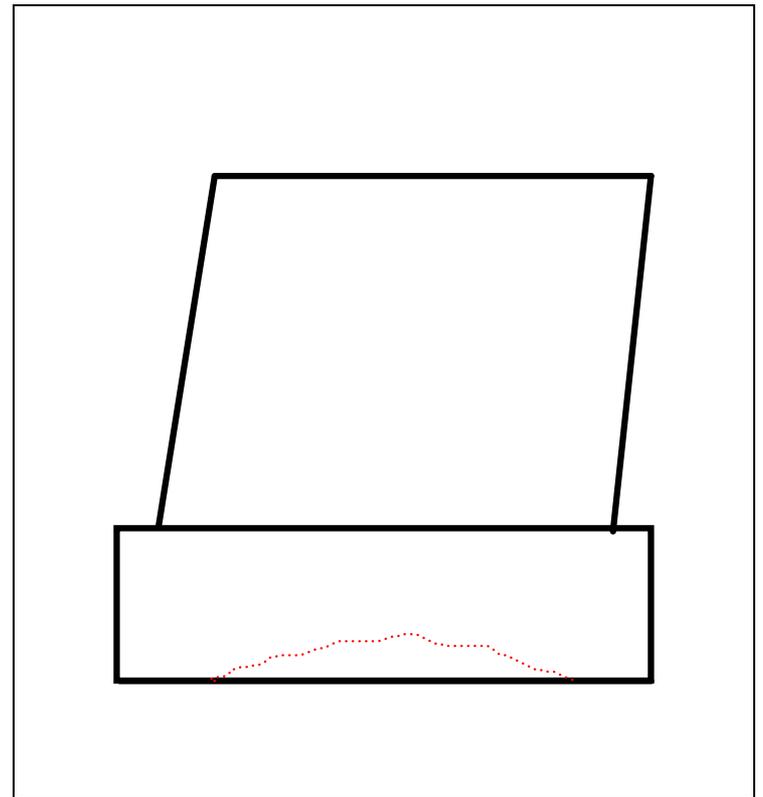
This ice cube is clear, solid but
it is oversized due to a too
long freezing cycle.

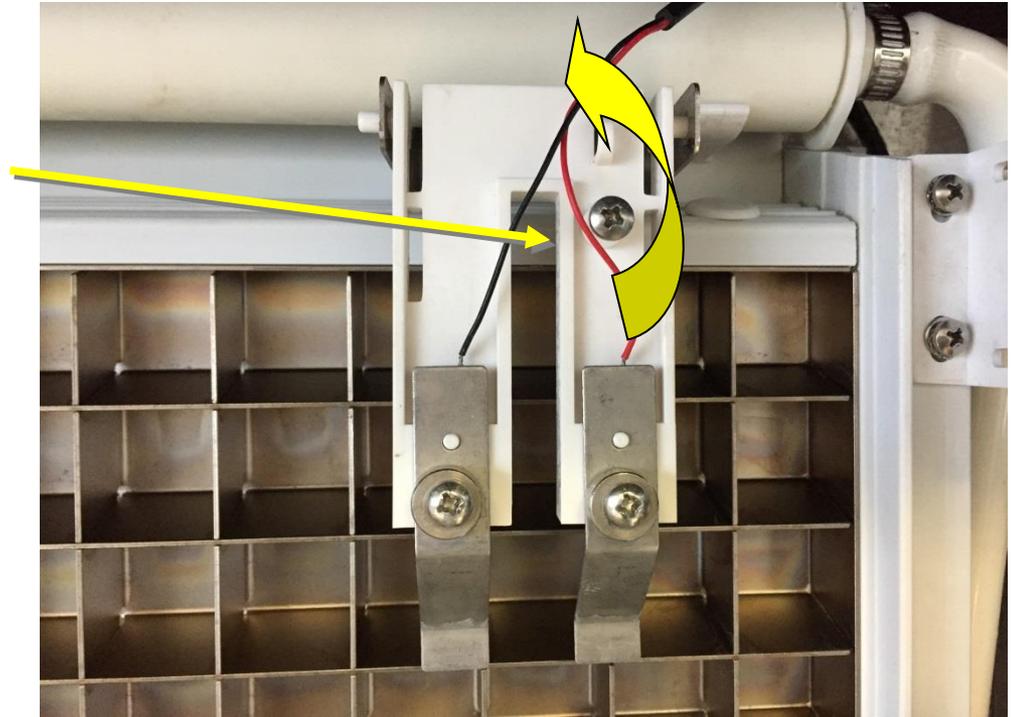
It is necessary to reduce the length of the freezing cycle by adjusting the clearance between the ice thickness sensor and the front of the evaporator turning the adjusting screw counterclockwise.

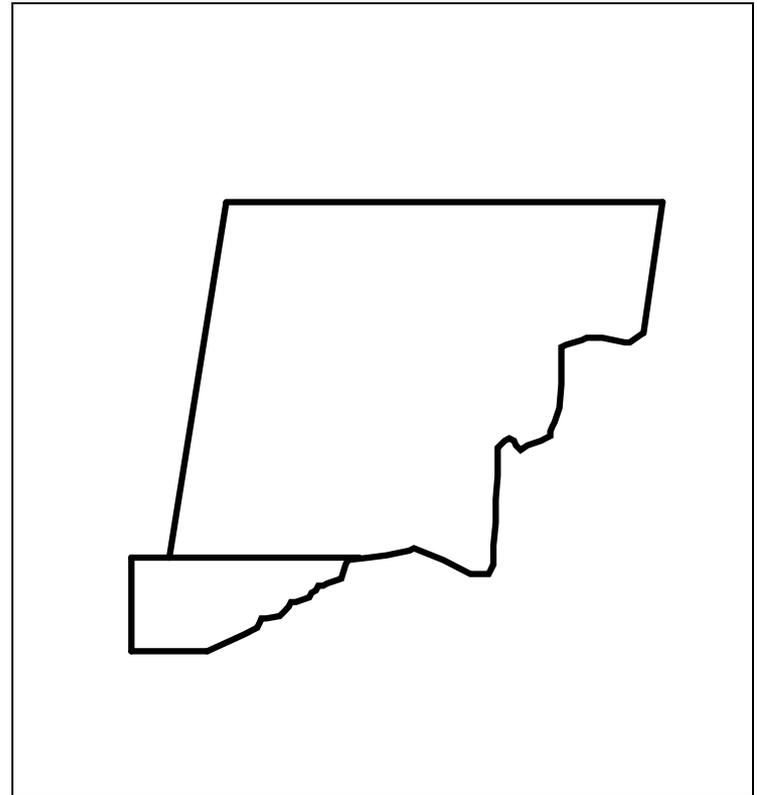
This is a typical ice cube clear on its upper left side and white and corroded on its bottom right side.

The reason is that the water doesn't reach in correctly the inside of some of the evaporator molds.

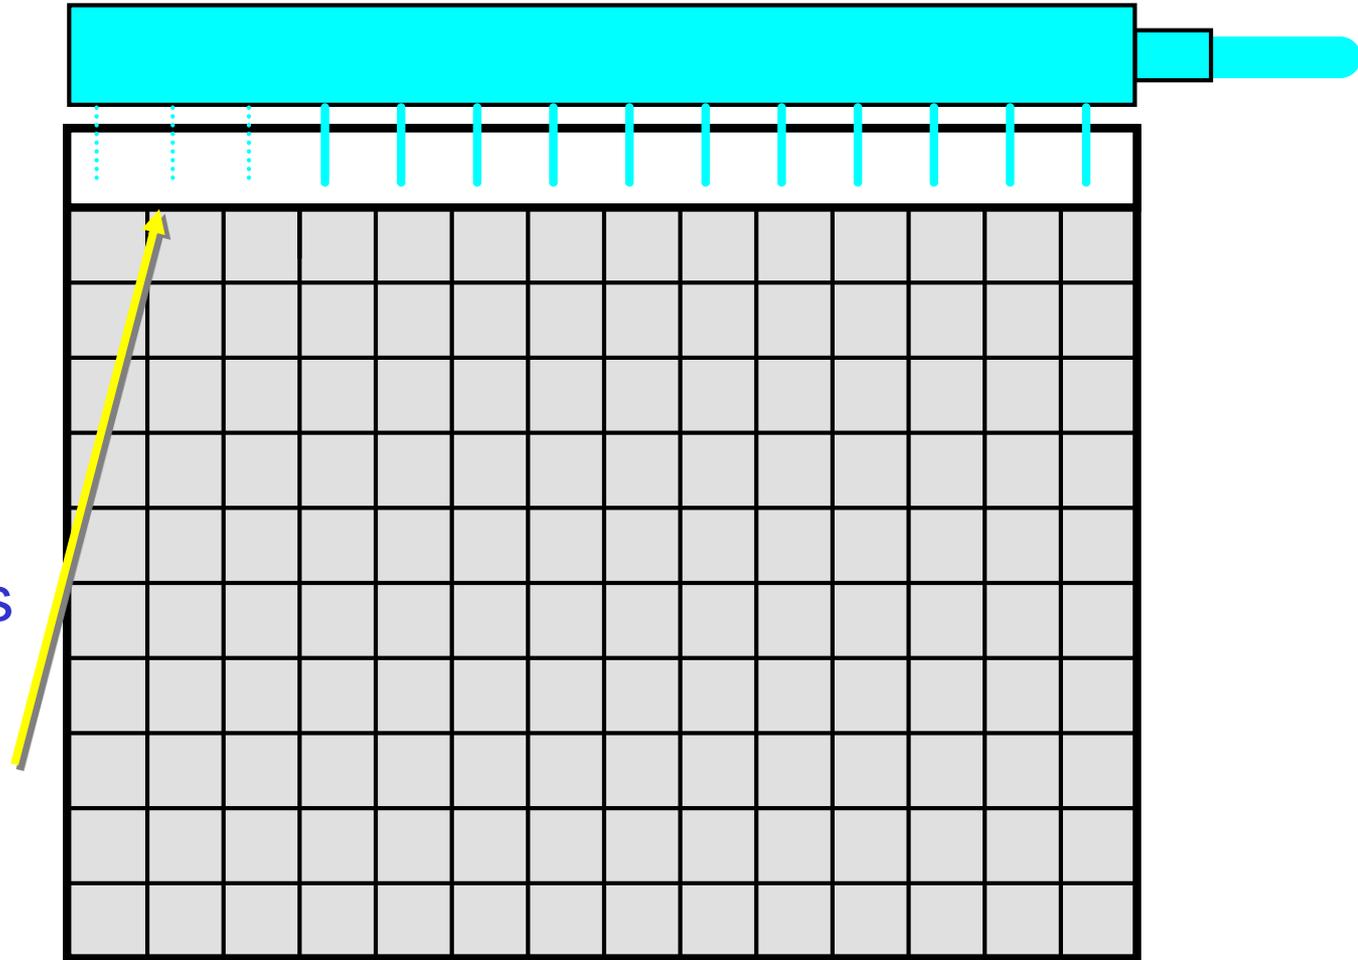
Should be due to
clogged spray jets

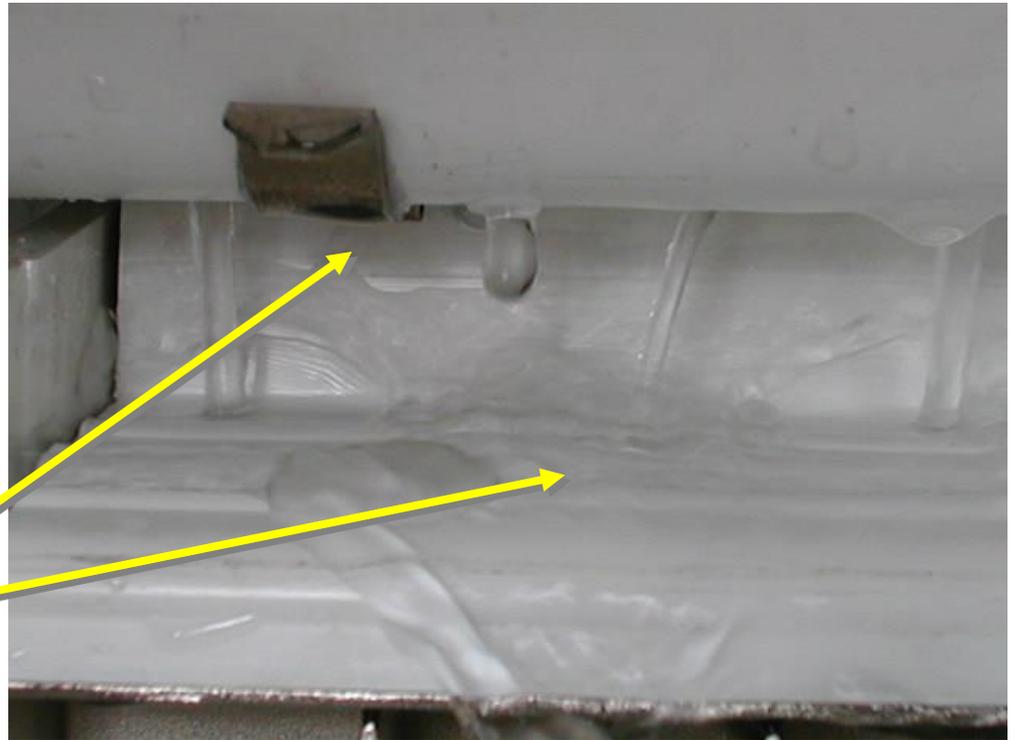
To solve this
trouble check and
clean spray bar as
shown on the
previous Cleaning
Procedures

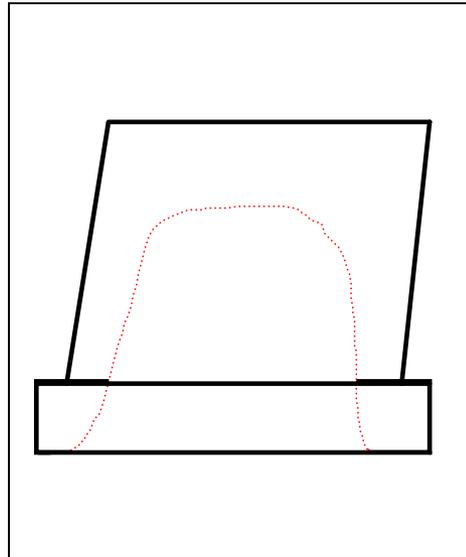
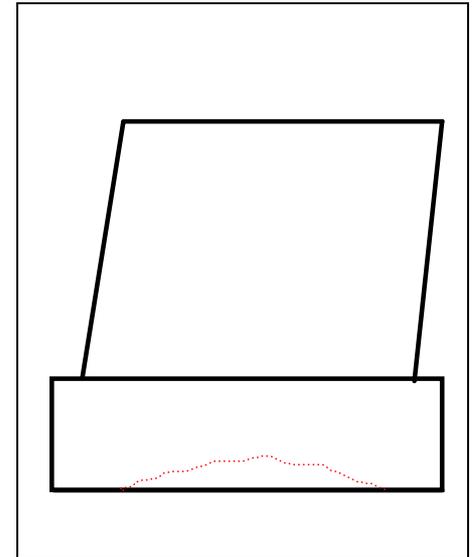
These ice cubes are both clear, solid but some are oversized and some other are undersized.

If so the possible reasons could be:

- **TXV not working properly**
- **Low refrigerant charge**

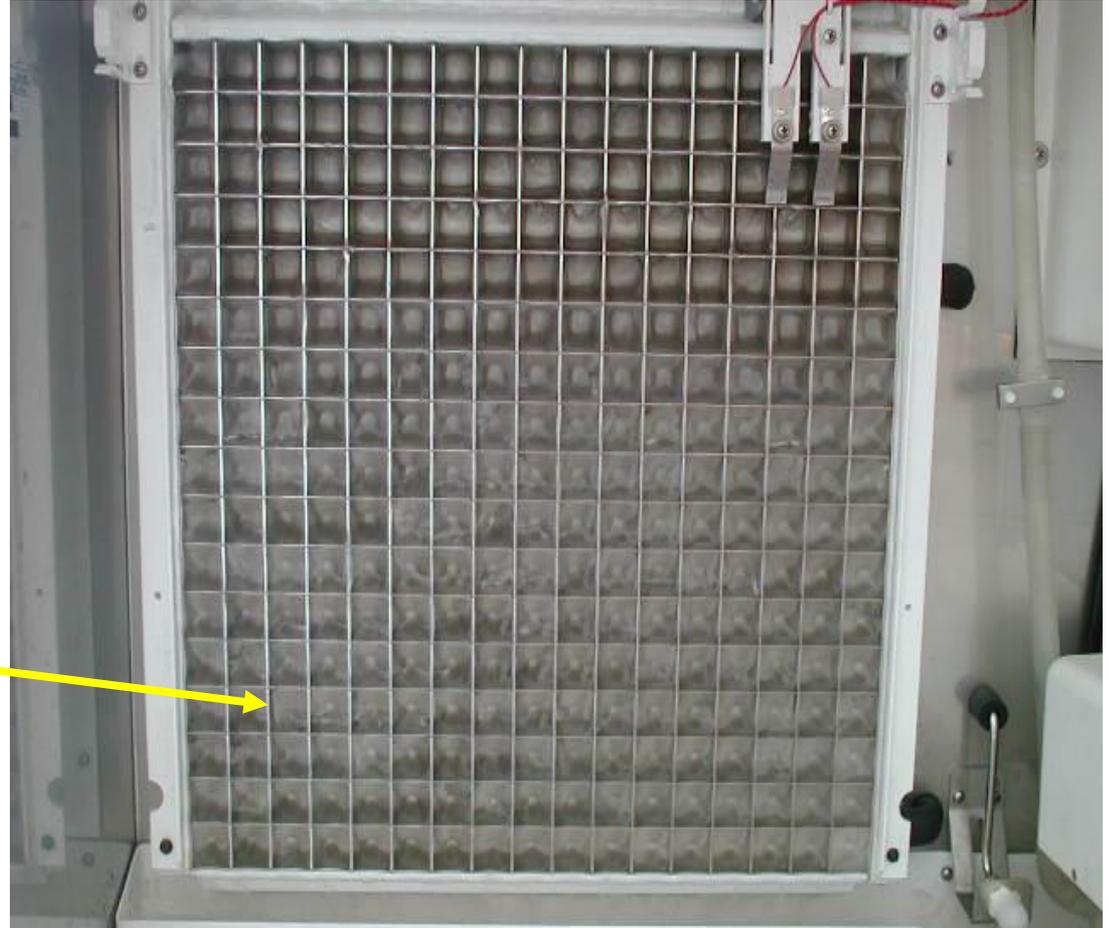
Looking the evaporator, after 15-20 minutes in the freeze, the ice is probably.....

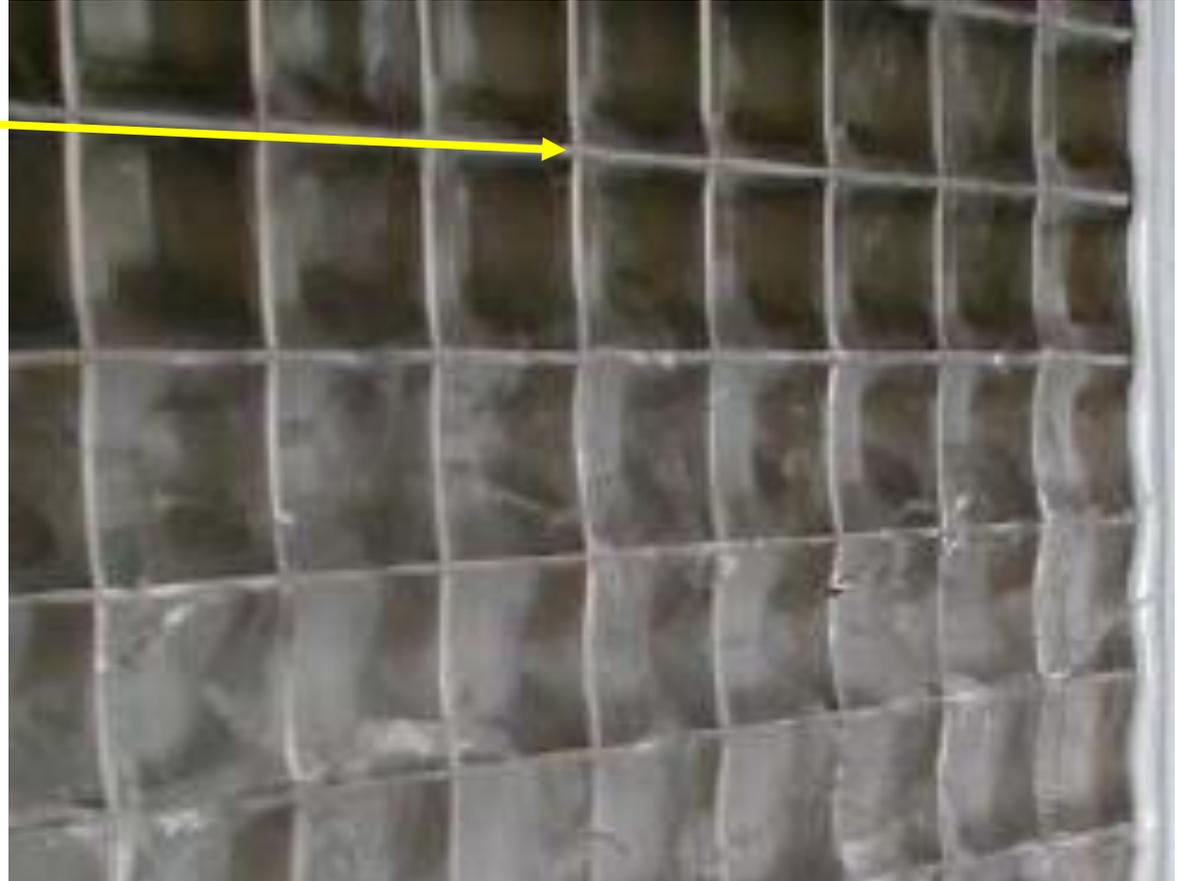
thick on the bottom portion (inlet of refrigerant) and thin on the upper one (outlet) due to the lack of exchange of heat between refrigerant - already in vapor state - and cascading water.

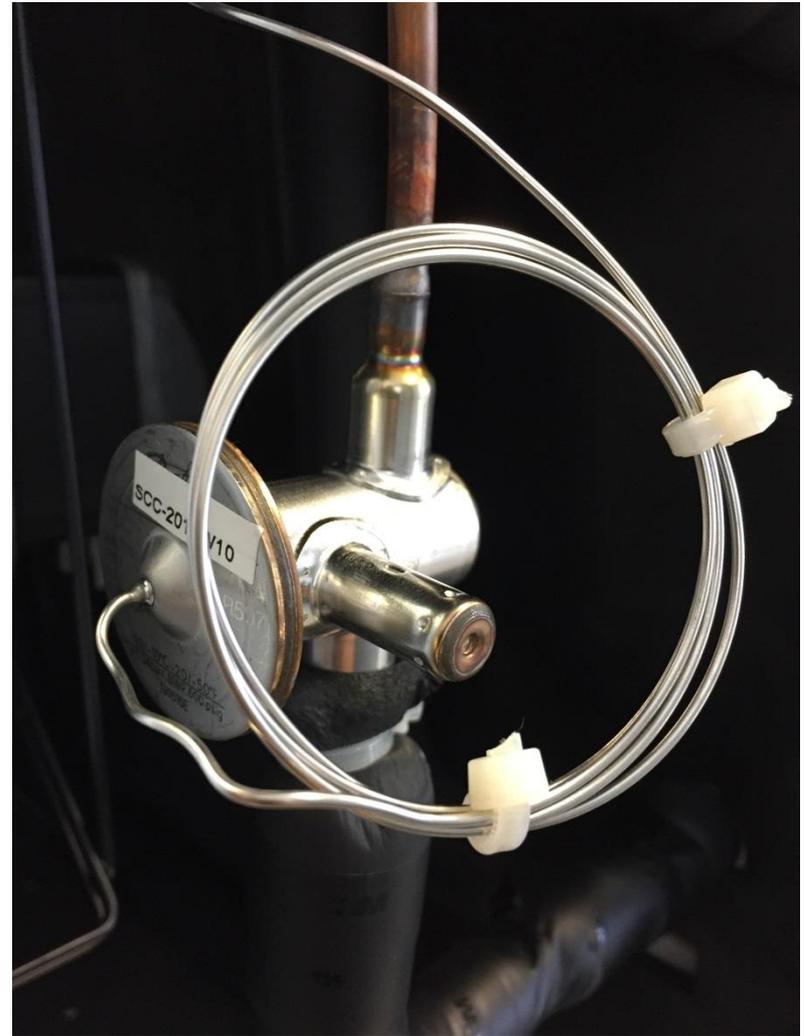
If the pressures are not the right ones, it will be necessary to replace the TXV valve

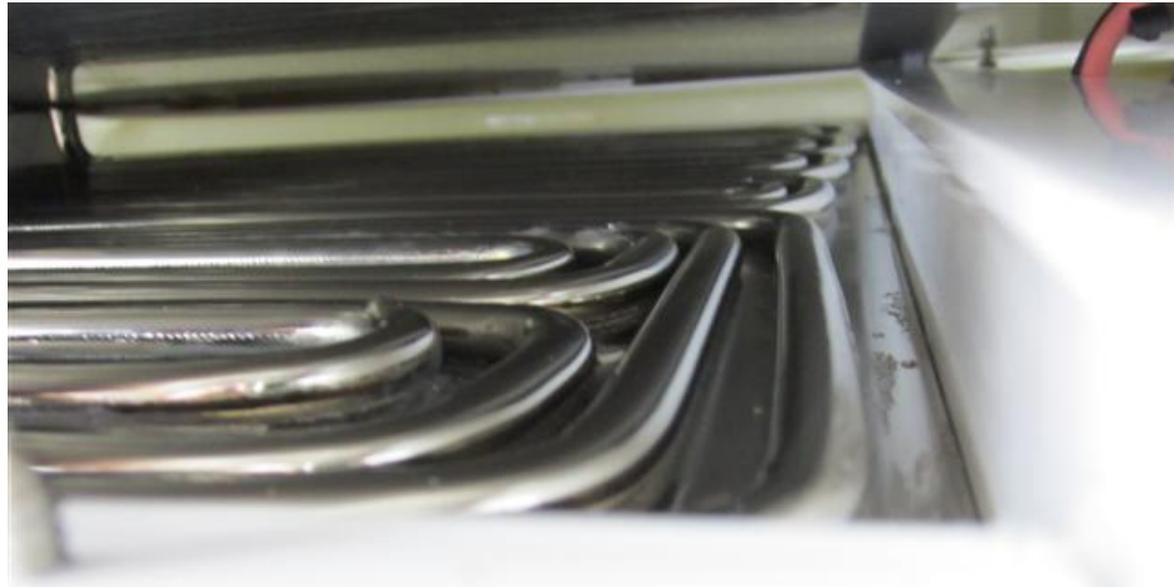
One more possible reason could be the serpentine no longer proper welded on the back side of the evaporator.

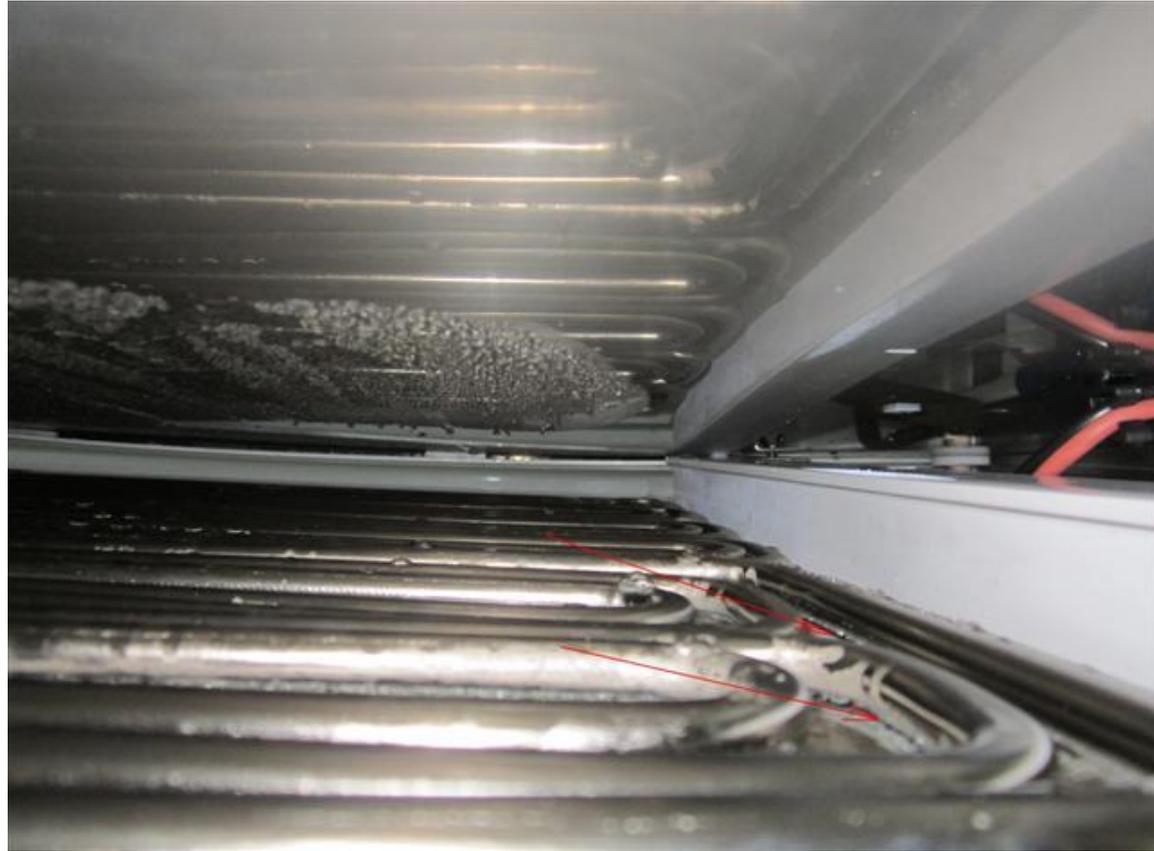
If so, ice is produced in spots, according to the different transmission of heat between the refrigerant in circulation on the serpentine and evaporator surface.
