Scotsman[®]
Ice Systems

NEW MXG SERIES

SECOND HALF

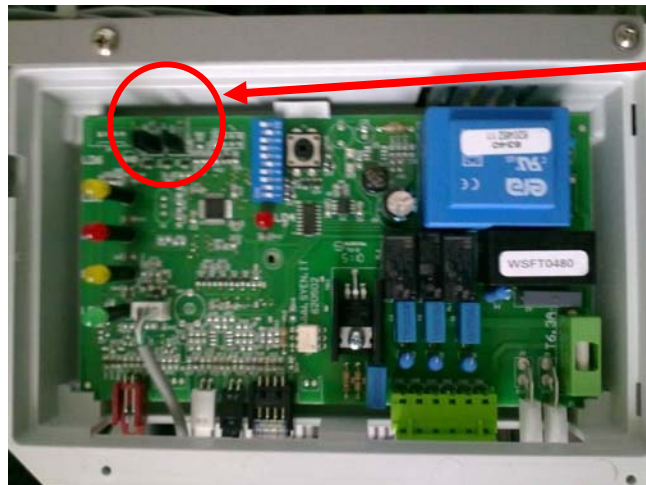
MXG series are equipped by a special built in countdown timer which advise about elapsed time which remind for cleaning. The time between cleaning/de-scaling can be changed according with PC Board

WATER SYSTEM CLEANING REMIND
 JUMP IN - 6 MONTHS
 JUMP OUT - 12 MONTHS
 RAPPEL NETTOYAGE SYSTEME
 HYDRAULIQUE
 CONTACT FERME' - 6 MOIS
 CONTACT OUVERTE - 12 MOIS
 RICHIAMO PULIZIA SISTEMA IDRICO
 CONTATTO CHIUSO - 6 MESI
 CONTATTO APERTO - 12 MESI

AC/EC MODELS
 JUMP IN - AC SERIES
 JUMP OUT - EC SERIES
 MODELES AC/EC
 CONTACT FERME' - SERIES AC
 CONTACT OUVERTE - SERIES EC
 MODELLI AC/EC
 CONTATTO CHIUSO - SERIE AC
 CONTATTO APERTO - SERIE EC

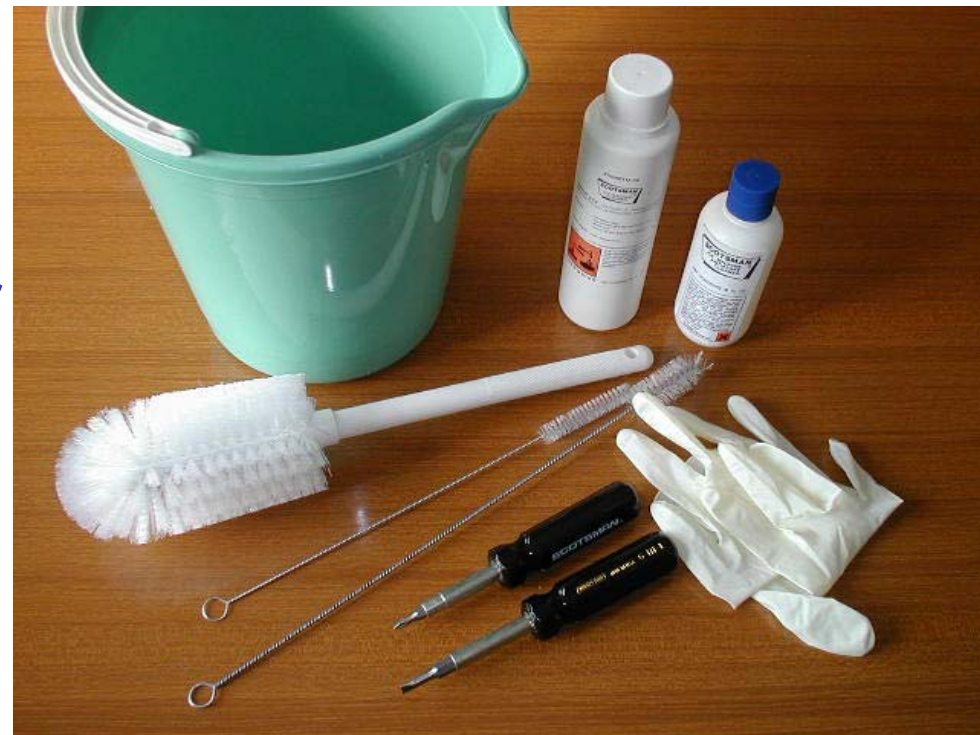
TOOLS REQUIRED

- Medium Phillips Screwdriver
- Medium Flat Screwdriver
- Pair of safety gloves
- Bucket
- Different types of brush
- Approved Cleaner/Sanitizer

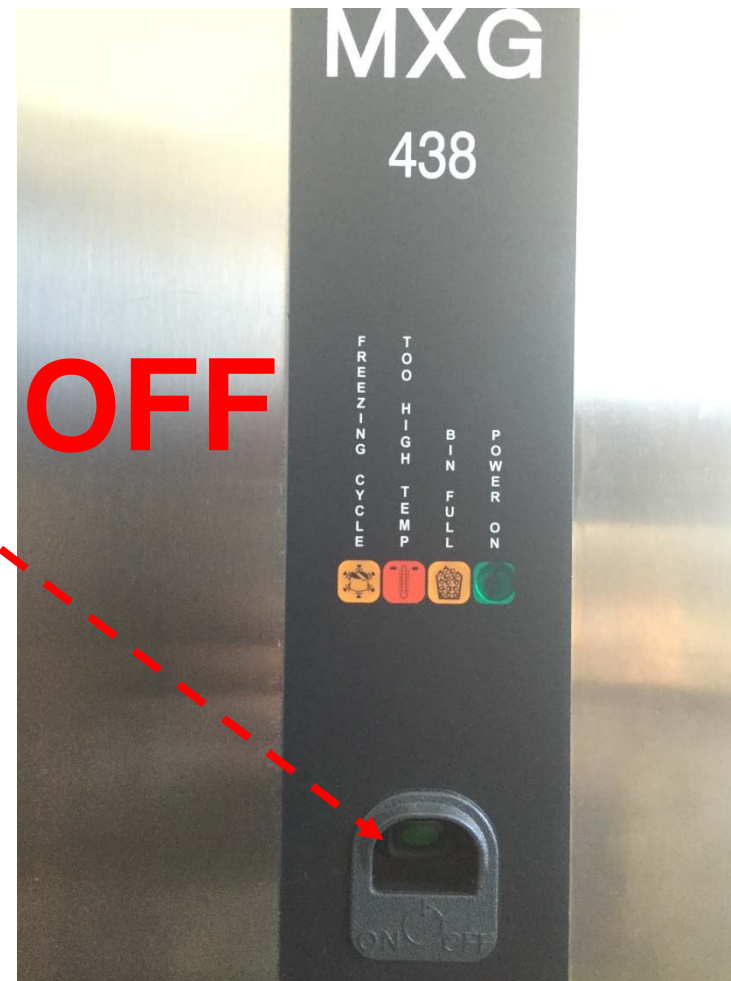
Wait till the end
of the
defrost/harvest
cycle then Switch
OFF the machine

Remove all frame
panels

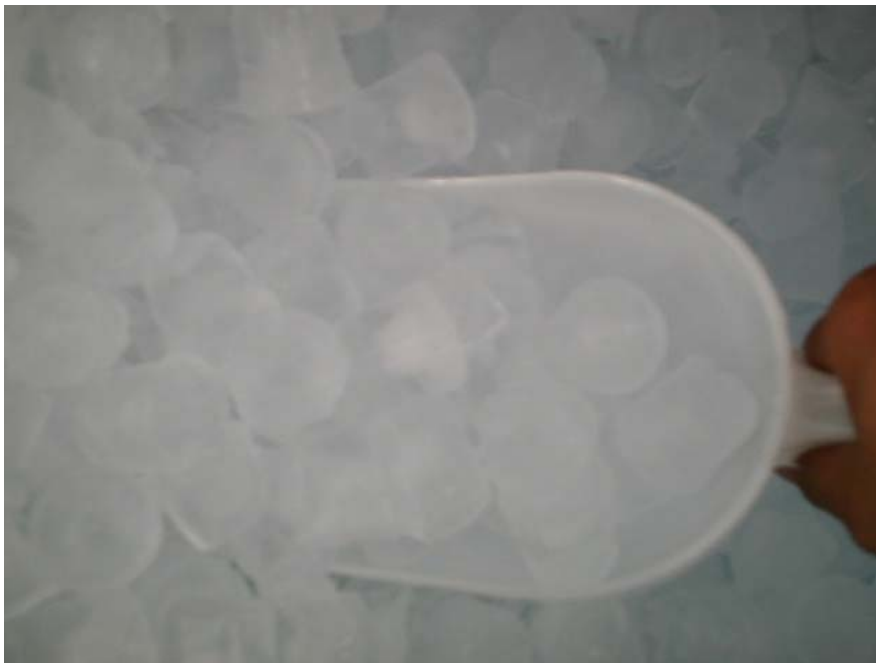
Scoop out all ice cubes stored into the bin so to prevent its contamination then...

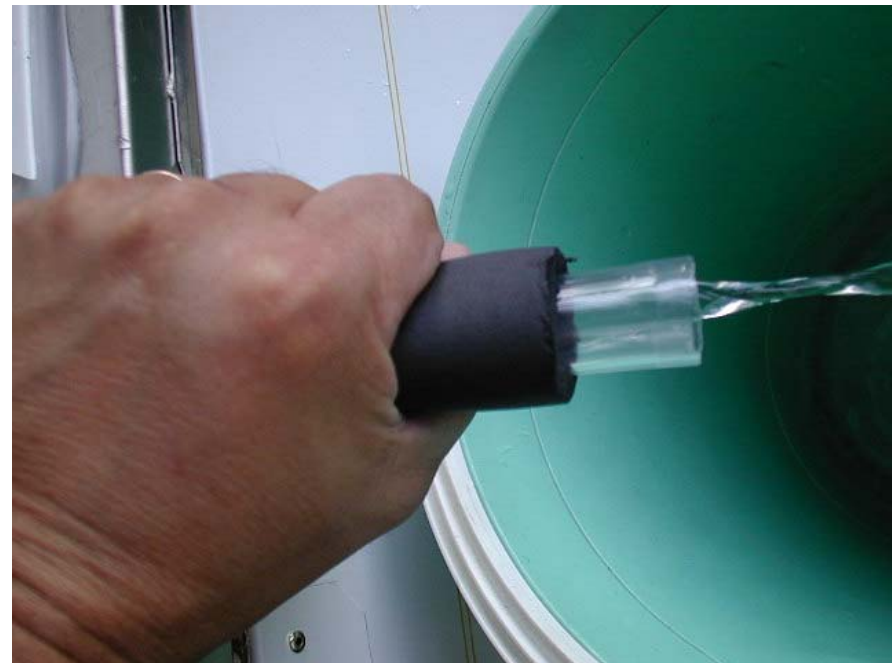
....flush out the water from the sump reservoir by bending down the drain tube.

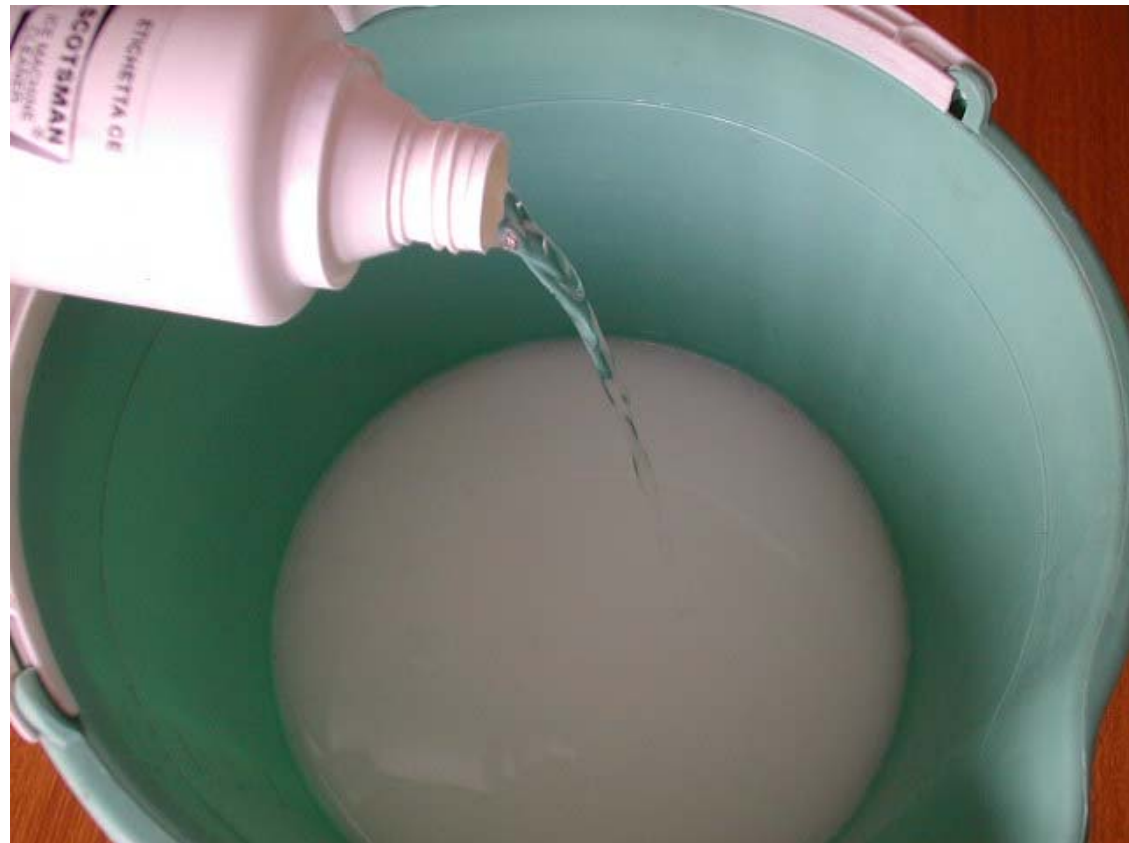
Prepare the cleaning solution by diluting in a plastic bucket three liters of lukewarm water (max 40°C) with 300 ml of **SCOTSMAN Ice Machine Cleaner**.

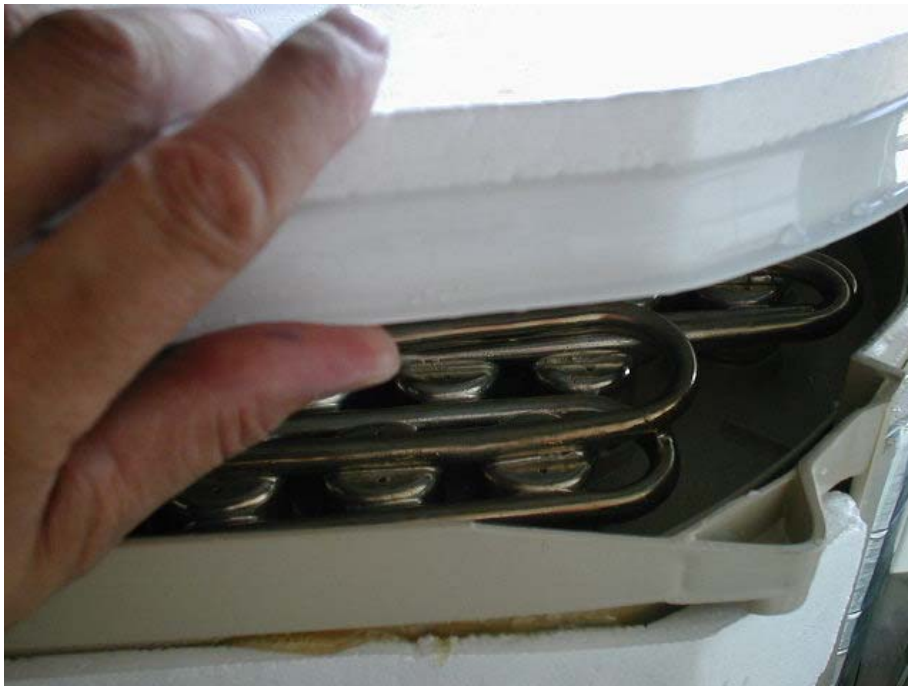
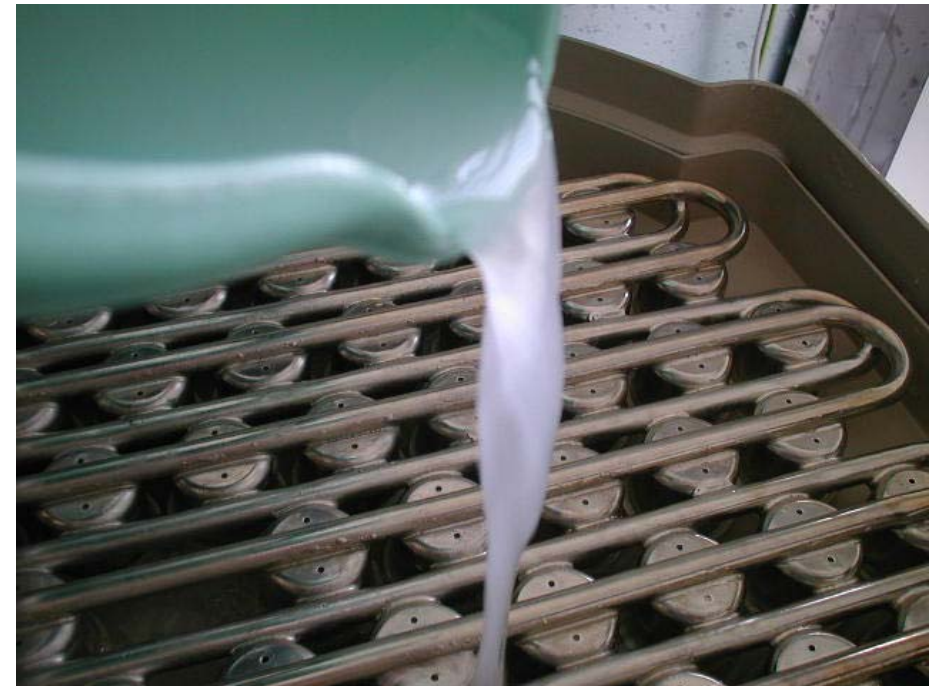
Remove the evaporator cover then....

....slowly pour onto the evaporator the cleaning solution.

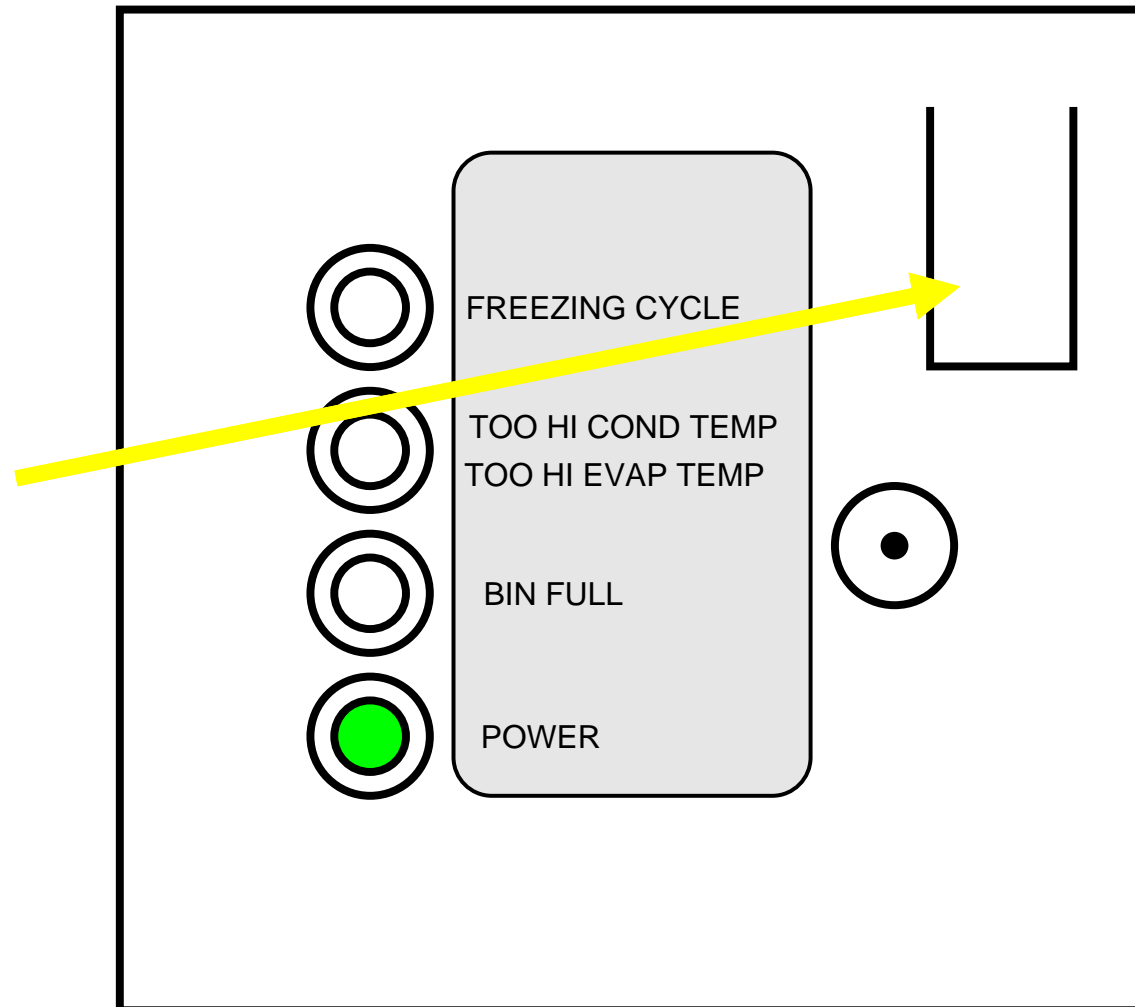
During the Water
Filling Phase push
the Re-Set button
between 2 and 5”.

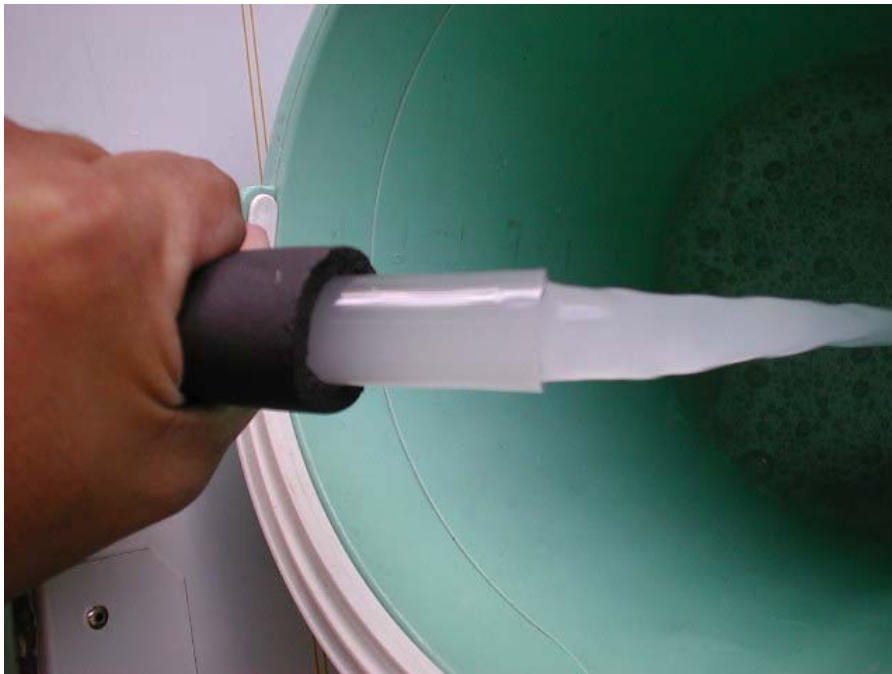
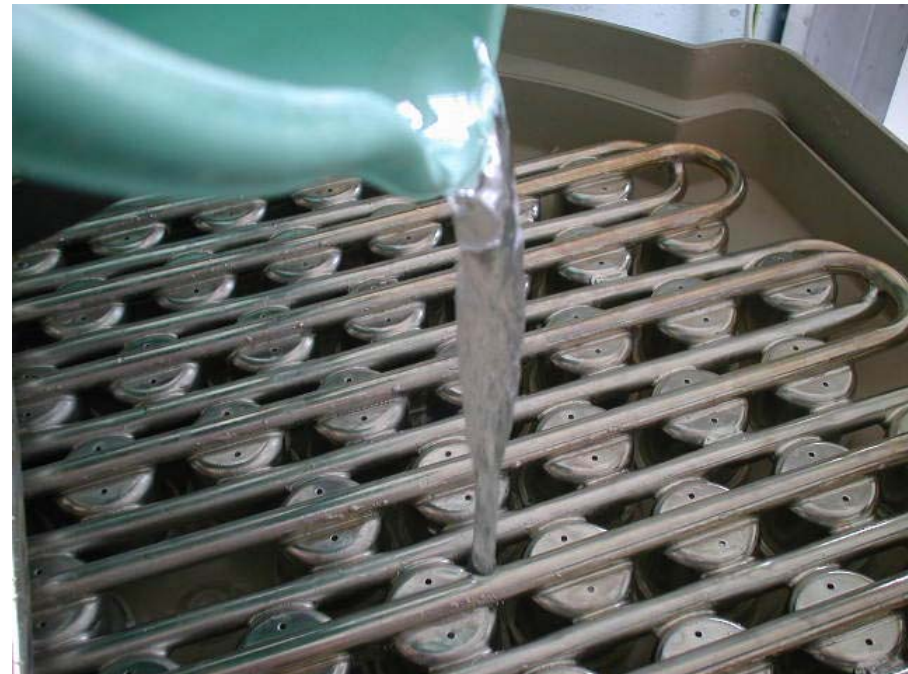
Flush out the cleaning solution from the sump by bending down the drain tube
.....

... pour onto the evaporator cavity three liters of fresh water to rinse the molds and the platen.

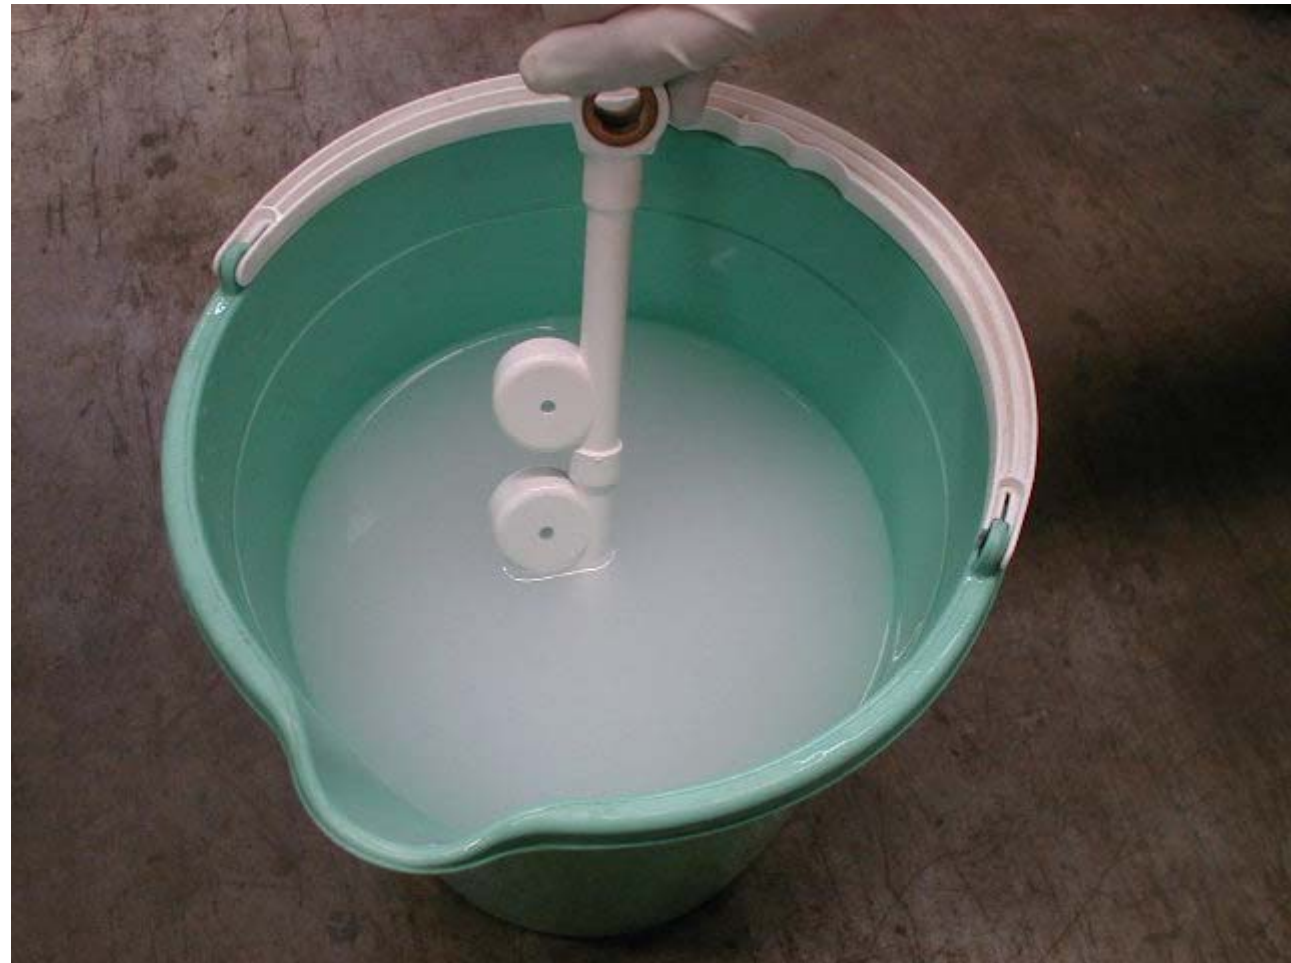
....then dump
into a
cleaning/de-
scaling
solution to
remove any
possible scale
formation from
the inside...

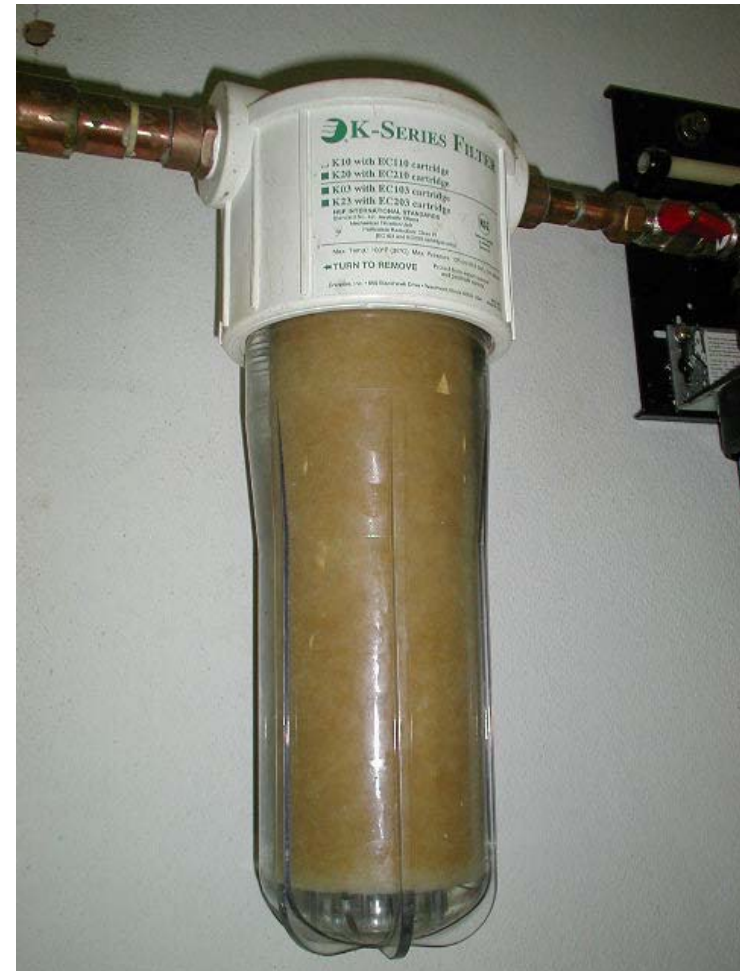
- Clogged water filter

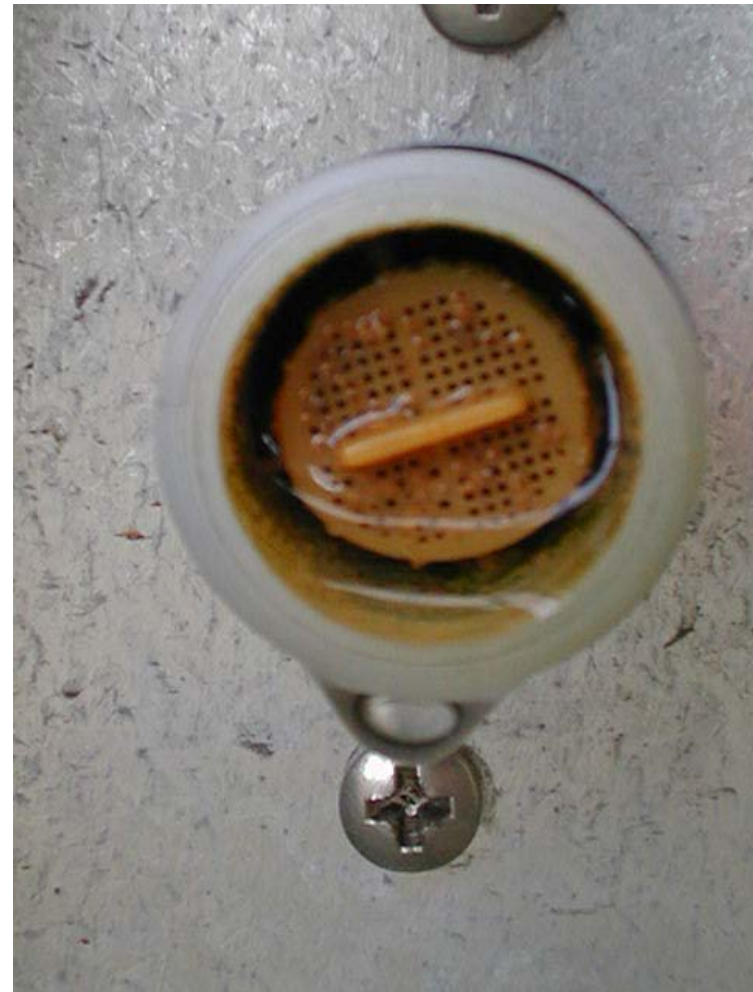
- **Clogged water inlet strainer**

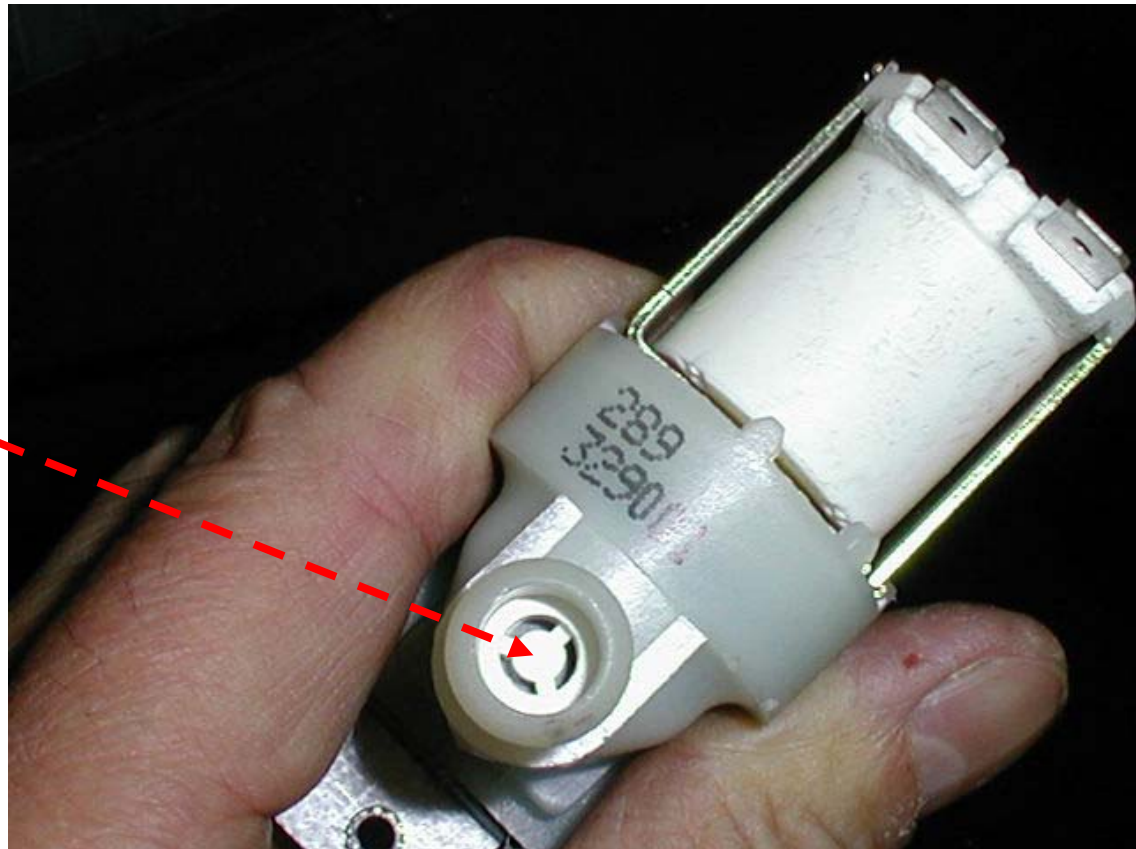
- **Clogged
water flow
control**

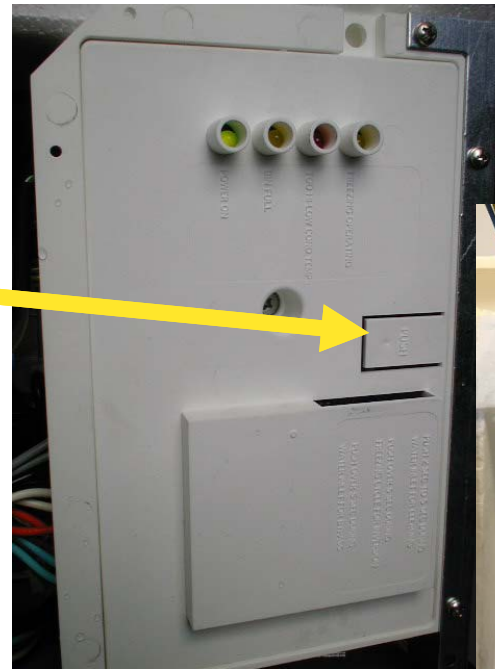
- Push and keep on pushing reset button.
- While keeping reset button pushing turn the unit ON by green switch

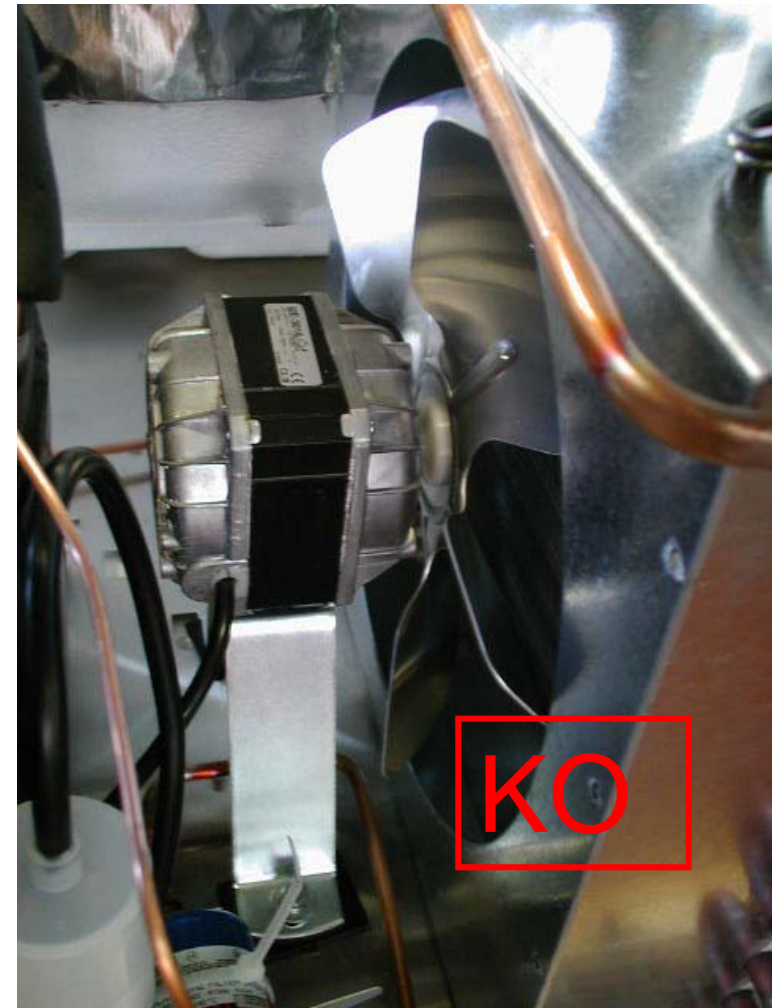
- Fan Motor (air cooled version) inoperative

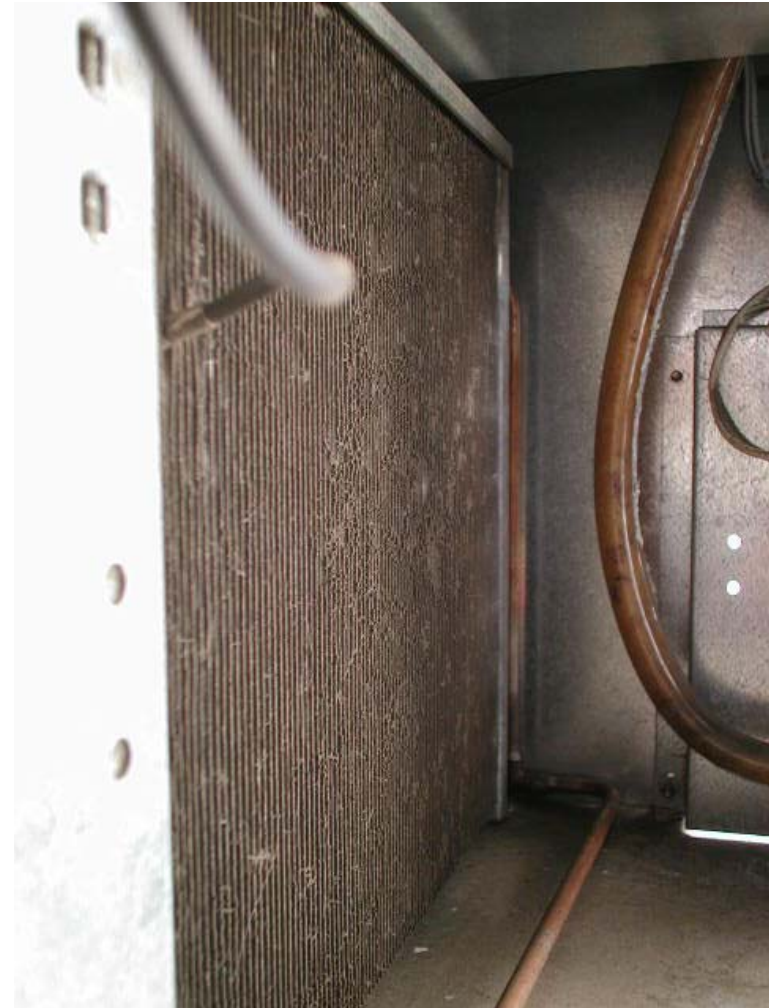
- **Dirty condenser**

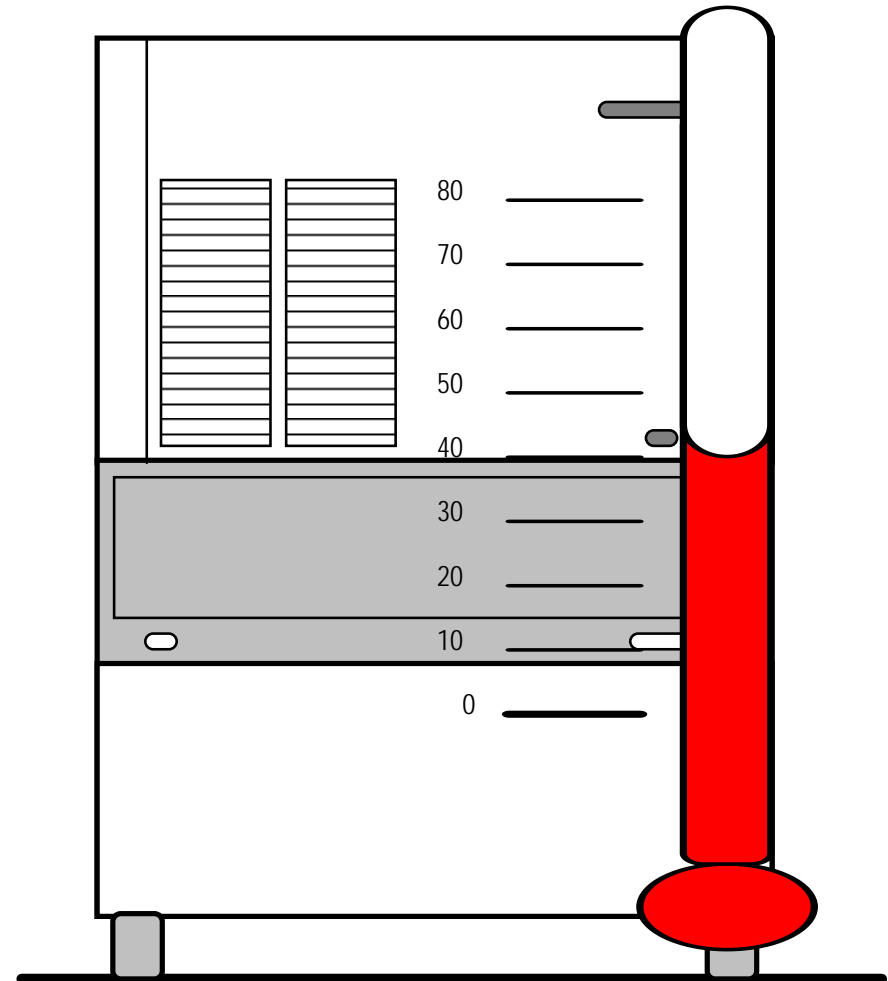
- Too high room temperature

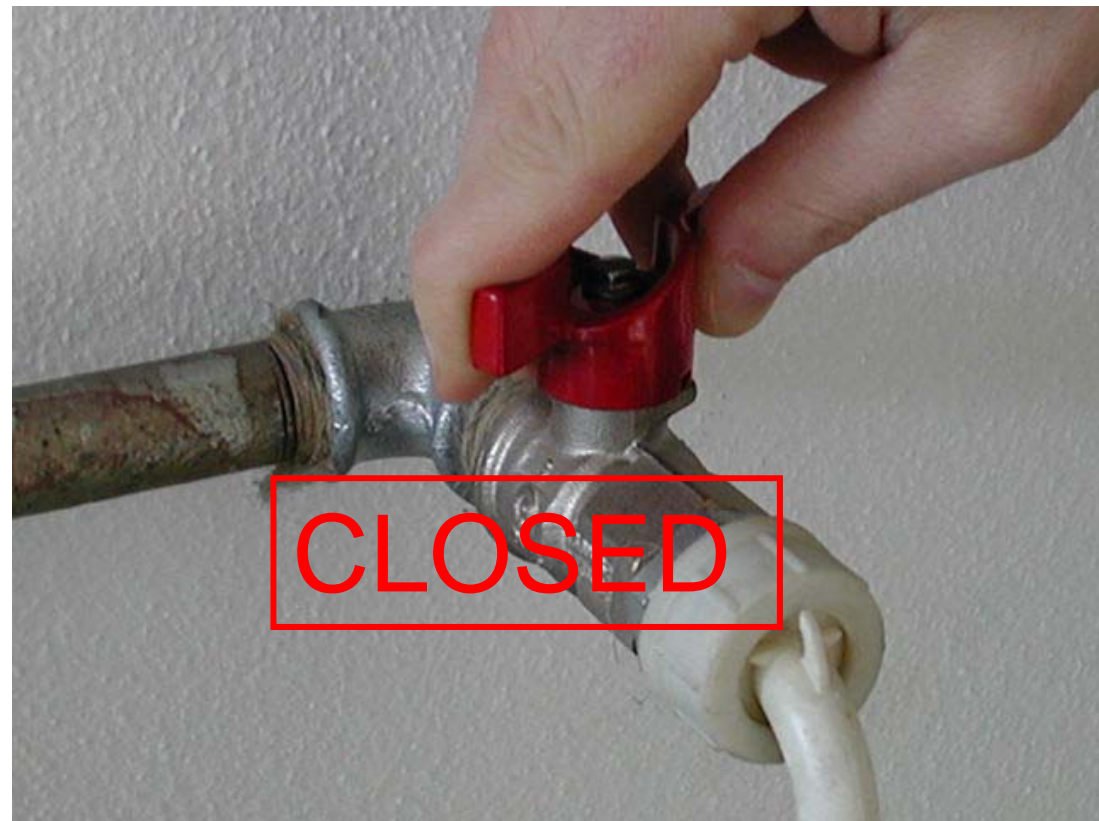
- No water to water cooled condenser

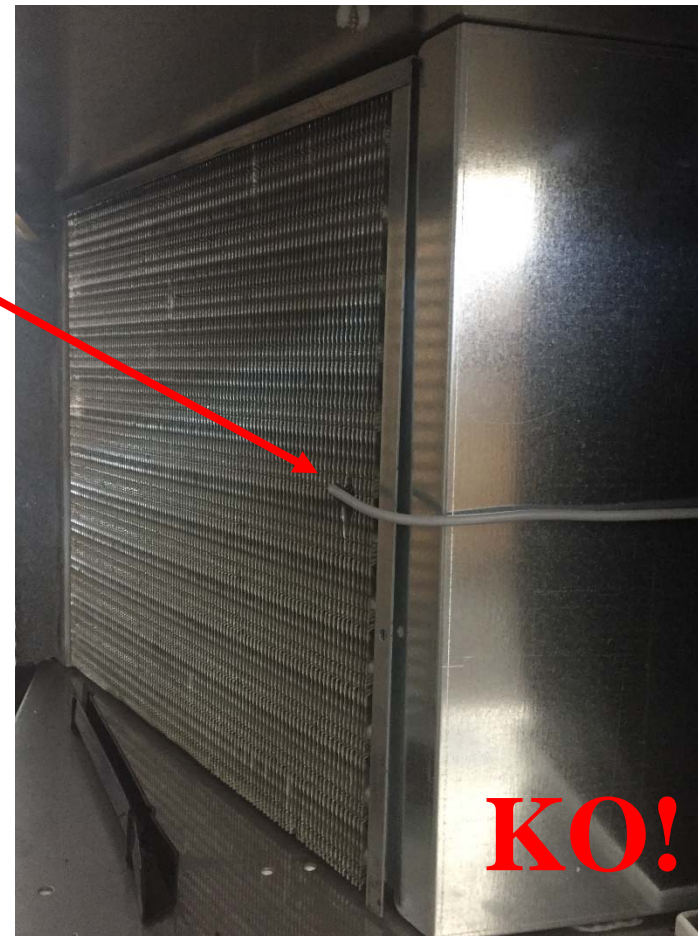
- Condenser sensor inoperative

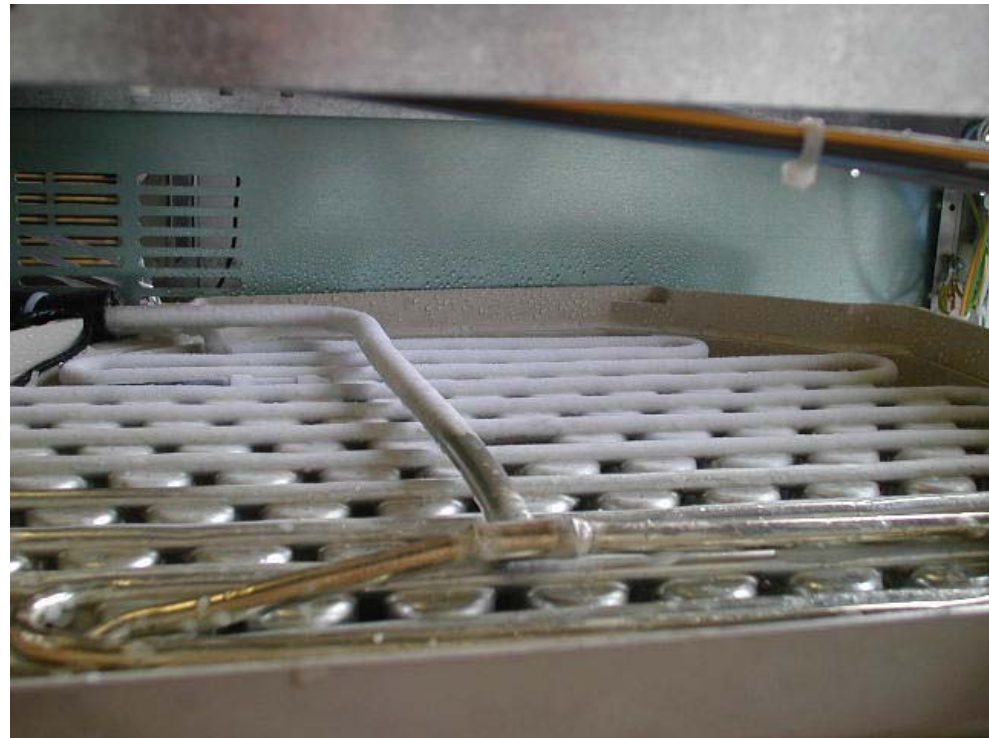
Short or no refrigerant in the system

Check during freezing cycle
for:

- **Proper frost of the evaporator serpentine**

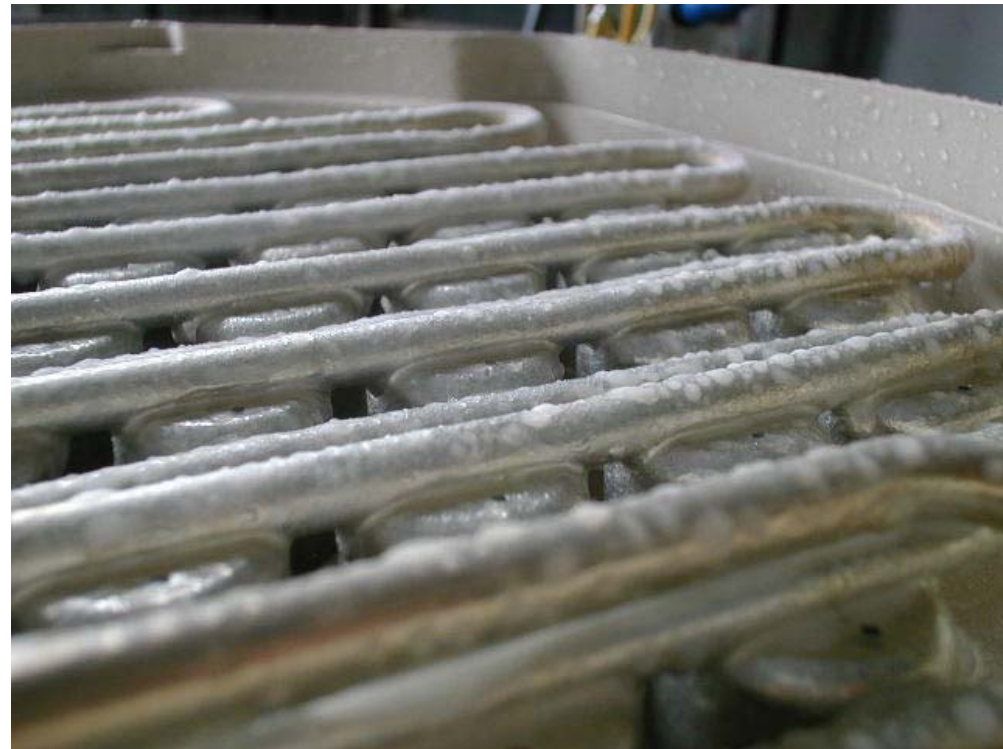
Leaking of refrigerant through the hot gas valve

Check during freezing cycle
for:

- **Very poor frost of the evaporator serpentine**

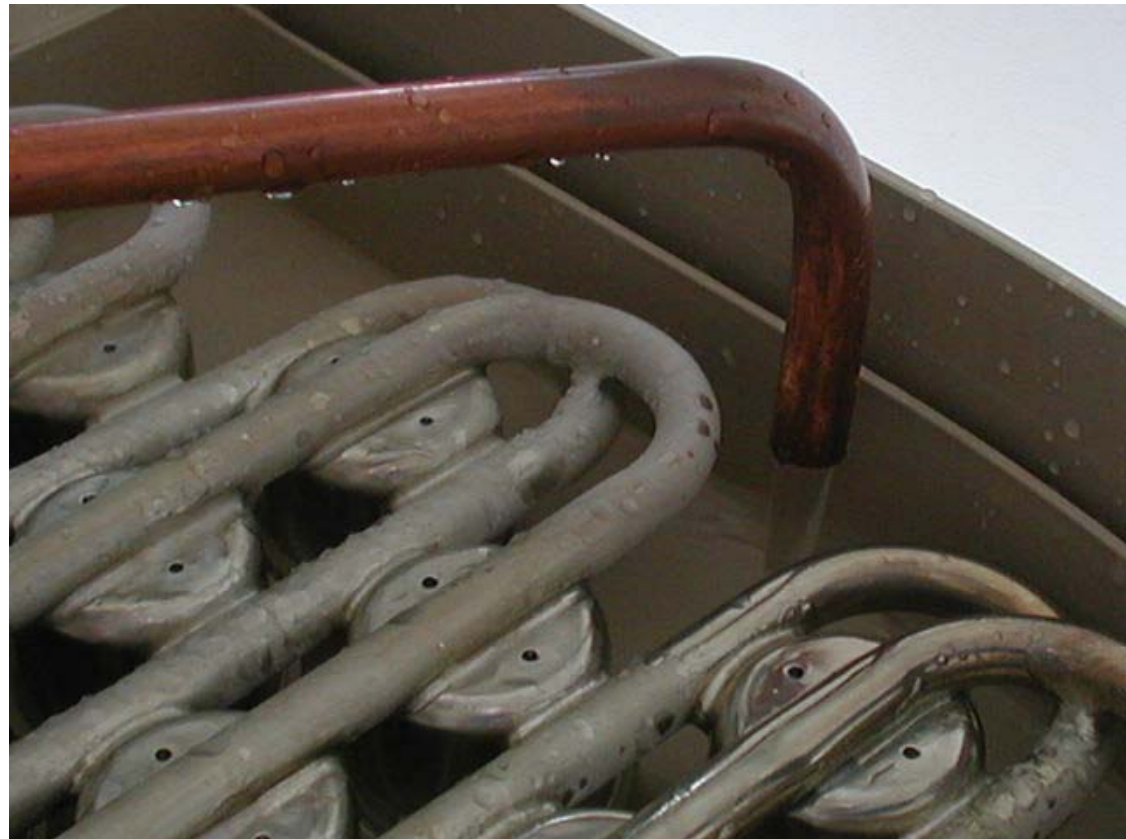
Leaking of water through the water inlet valve

Check during freezing cycle for:

- **Water flowing through the water inlet tube**
